Editor's Desk

Collision on Shigaraki Kogen Railway on 14 May 1991

Derailment and Collision at Naka Meguro on Hibiya Subway Line, Tokyo on 8 March 2000

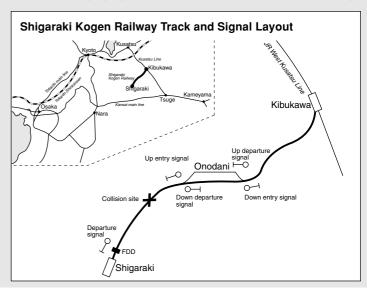
On 14 May 1991, Shigaraki was crowded with people visiting 'The World Ceramic Festival.' At 1014, a four-car DMU train was about to start from Shigaraki for Kibukawa but the duty stationmaster could not turn the departure signal to green. The control panel showed another train approaching, but he could not understand the situation, because he knew there was no approaching train. The next arrival was a JR West special train from Osaka but it should still have been at Kibukawa Station. He consulted SKR's operations manager and a signalling engineer, but they could not turn the signal to green either. Finally, the operations manager decided to let the train go by non-blocking operation and got into the cab with an extra driver to act as pilot. The SKR train left Shigaraki 11 minutes late with the signal still showing red in defiance of the duty stationmaster's opinion.

The JR West special train from Osaka left Kibukawa Station at 1018. The two trains were scheduled to pass at Onodani, the intermediate signal station. When the JR West train arrived at Onodani at 1030, the SKR train was not there and the departure signal showed green, allowing the JR West train to proceed. The JR West driver passed Onodani, believing that the SKR train was still at Shigaraki for some reason. As he rounded a sharp curve, he found the SKR train coming head on. The two trains collided at 1035, killing 42 people including the SKR train driver and other staff (see photograph on page 20). The JR West driver was severely injured but survived. More than 600 people were injured.

preventing the opposite train from entering the same section. This precedent may have made the operations manager overconfident about the FDD. 2. The FDD did not work because of faulty wiring by a signal engineer who was wrongly inspecting relays under the supervision of the track and signalling manager as the train departed. 3. The reason why the Shigaraki departure signal could not be turned to green was complex. JR West did not like delayed SKR trains affecting its operations on the Kusatsu Line, so in 1990, it installed a special device called a Direction Priority Lever (DDL) on the control panel at the Kameyama CTC Centre, controlling the Kusatsu and Kansai lines. By using the DDL, JR West dispatchers could lock the SKR departure signals at red in order to give priority to Shigaraki-bound trains. JR West insisted that SKR had been duly informed, but SKR claimed it had never received any notice. In March 2000. Otsu District Court ruled that the

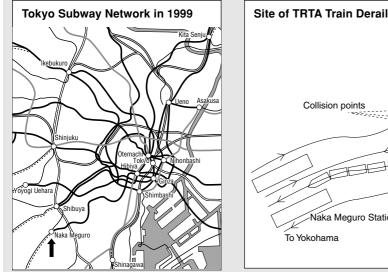
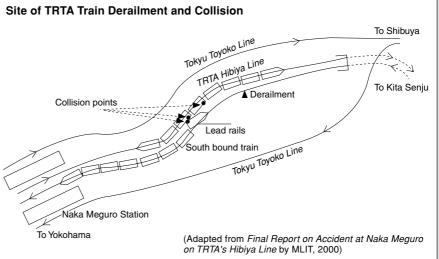
At 0901 on 8 March 2000, when a southbound Hibiya Line eight-car EMU owned by Teito Rapid Transit Authority (TRTA, a Tokyo metro operator) was approaching Naka Meguro Station at 12 to 13 km/h, the two axles of the front bogie of the last car suddenly derailed. A trackside lead rail installed for setting off track maintenance vehicles caused the derailed 8th car to slew further right, hitting the 5th and 6th cars of a northbound eight-car EMU (owned by Tobu Railway). The southbound TRTA EMU stopped a few seconds after the collision when the conductor applied the emergency brake; the northbound Tobu EMU stopped automatically because the brake air pipe was broken between the 5th and 6th cars. The 8th car of the southbound train and the 5th and 6th cars of the northbound train were severely damaged, killing five passengers and injuring 63 others (see photograph on page 21).

After 21 meetings, a 107-page final report was published in October 2000. The report noted that multiple factors caused the southbound train to derail at this particular spot. They included:

- Unbalanced static wheel load, causing extremely decreased wheel load and increased lateral thrust to outer wheels running on curve
- Increased coefficient of rail–wheel friction due to setting of rail lubricator, causing undesirable increased lateral thrust
- Track irregularity, especially twist and diminishing cant, causing decreased outer

wheel load

- Performance of axle suspension possibly contributing to undesirably decreased outer wheel load
- Combination of wheel and rail profiles, leading to increased lateral thrust
- Low-speed running at 12–13 km/h, preventing increase of outer wheel load by centrifugal force
- High air suspension rigidity against bogie rotation causing increased lateral thrust

The report concluded that these factors had been compounded to such a degree that the flanges of the outer wheels rode up over the rail head to finally derail. It also examined the structure of the damaged rolling stock and the conditions of the lead rails to set off track maintenance vehicles.

To prevent similar accidents, the report proposed stricter control of static wheel load; proper management of track regularity, especially flatness; appropriate management of rail profile after grinding; increase of flange angle from current 60° to 65° or 70°; and installation of anti-derailment guardrails at sharp curves. The report also proposed further studies on improved methods for measuring static wheel load, improved rolling stock performance at curves, better track design at sharp curves, and new rolling stock impact design to minimize passenger injuries.
