The Niigata Chuetsu Earthquake —Railway Response and Reconstruction

Masahiko Ogura

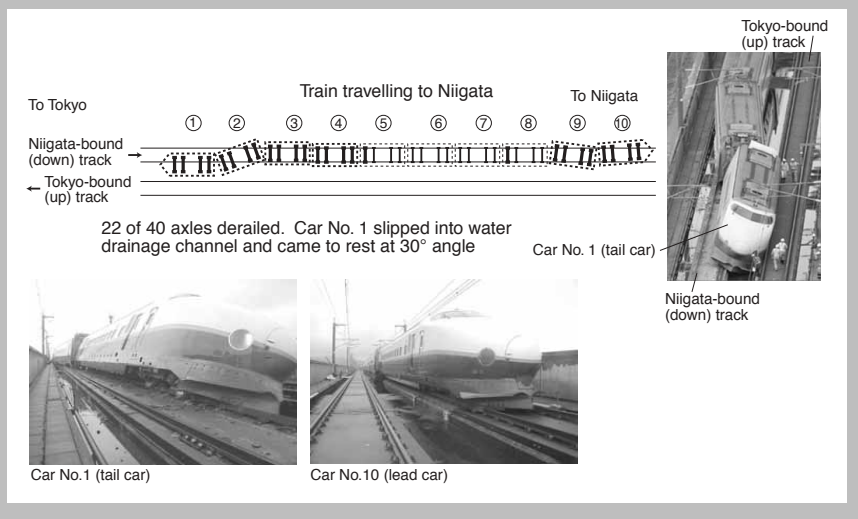
Figure 5 Situation after Derailment

As I explain in greater detail later, cars 5, 8, 9 and 10 were slightly affected, cars 6 and 7 were unaffected, and cars 1 through 4 were badly derailed with car 1 shifting a long way towards the Tokyo-bound track and coming to rest at an alarming angle.

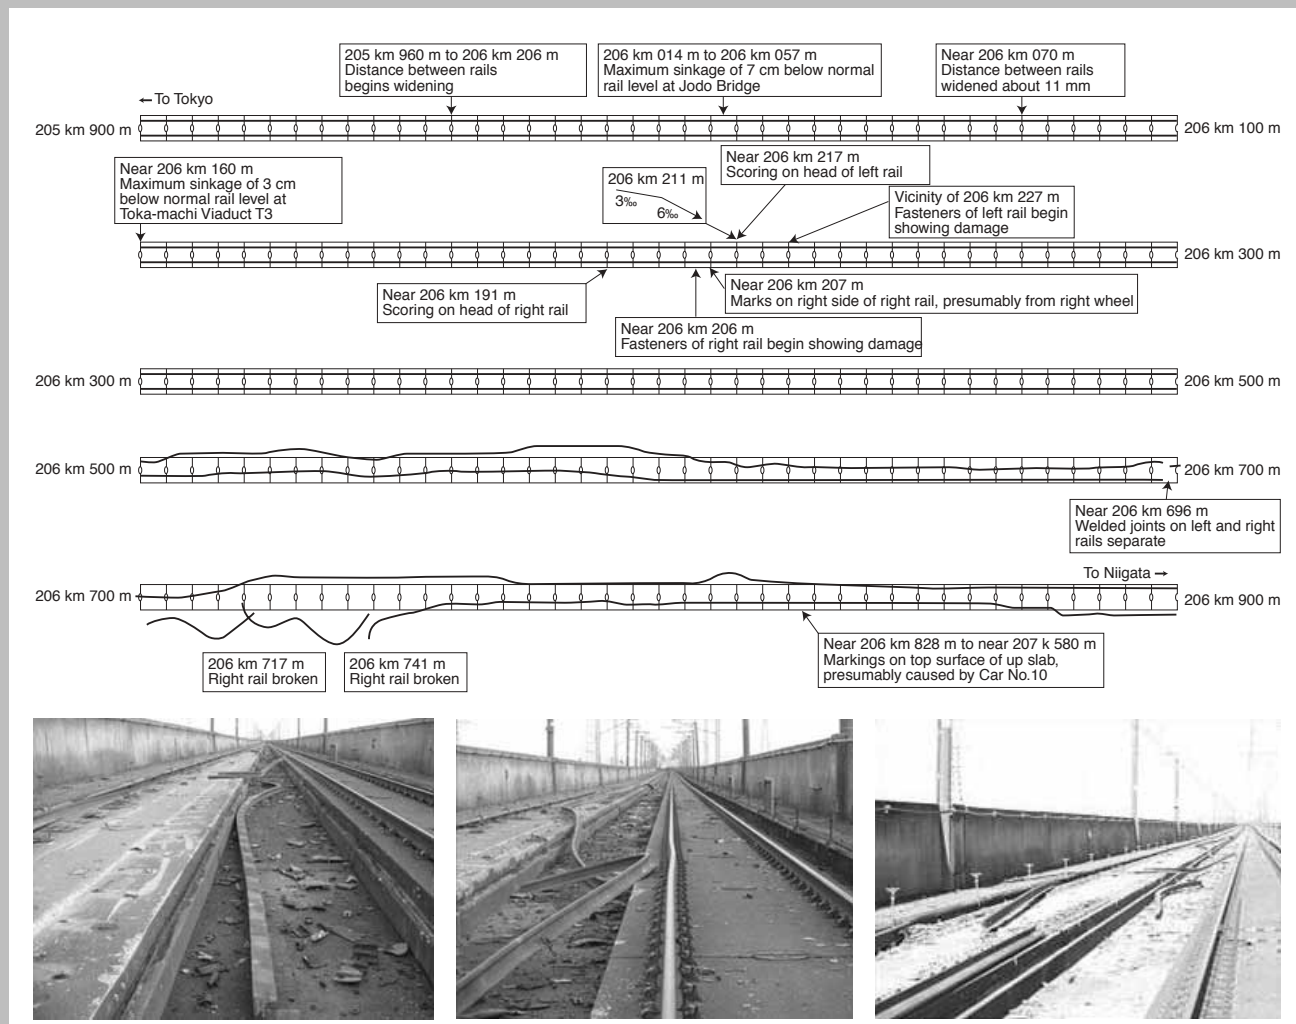
Figure 8 Damage to Railway Infrastructure near Shinkansen Derailment Site

Figure 8 shows the track in the general area of the derailment. I will explain the general mechanism of the derailment without getting too technical. Figure 8 has five parts, the top left shows the track closest to Tokyo, the bottom right closest to Niigata. The figure 206 km 191 m (meaning distance from Omiya base) near

the middle of the second section from the top was where we found marks indicating that wheels had mounted the right rail. The rails were badly deformed from the area shown on the left of the fourth section. Because the construction is a slab track, it was obvious that the rail fasteners here had been ridden over by the wheels. The rail was broken in three places as shown in the bottom of the figure. The train ran about 1.6 km from where the wheels first mounted the rail to where it finally came to a stop.

Next, I went to inspect the track where the derailment began. My first impression was that although the rails were badly twisted and had been severely thrown out of alignment in places, the concrete slab track itself was in good condition. The train had run on the slab, causing some damage, but the slab remained almost unbroken. Basing my judgment on past experience, I

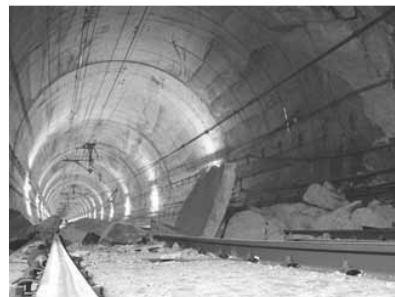
Uonuma Tunnel

more than 8-km long, was badly damaged in three places, with cracks in the tunnel arch and upheaval in the slab. The Myoken Tunnel was quite seriously damaged in two places.

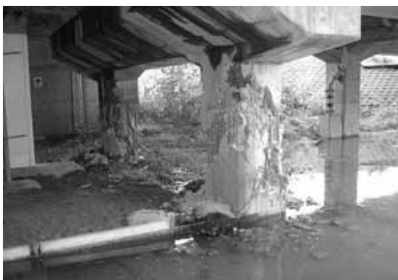
No. 1 Wanazu Viaduct

Some viaduct columns suffered shear-induced damage, with concrete falling away to expose the reinforcing bars. The Uonogawa Bridge (Fig. 9, bottom right) looked awful with exposed reinforcing bars after concrete broke off about halfway up the columns.

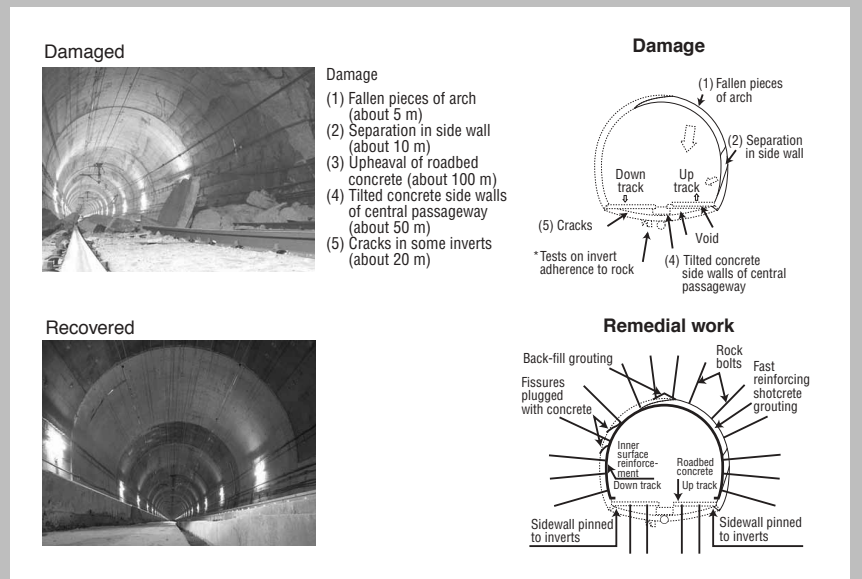
Figure 11 Damage at Uonuma Tunnel

We were most worried about fissures or gaps between the concrete inverts, roadbed concrete and bedrock, but there was no way of knowing without peeling back the concrete facing. There was no time to peel back the facing throughout the entire tunnel, so we drilled holes every 20 m to obtain samples. This was long and frustrating work, but it helped us to eventually decide to tell the public on 19 November when we hoped to resume services.

had made the tunnel stronger than it was before. Figure 11 shows how we inserted rock bolts into the bedrock to reinforce the tunnel structure and prevent lining collapse. We also installed fibre-reinforced concrete plates from the inside. In some cases we also inserted rock bolts through the tunnel flooring into the bedrock, making tunnel stronger than it had ever been.

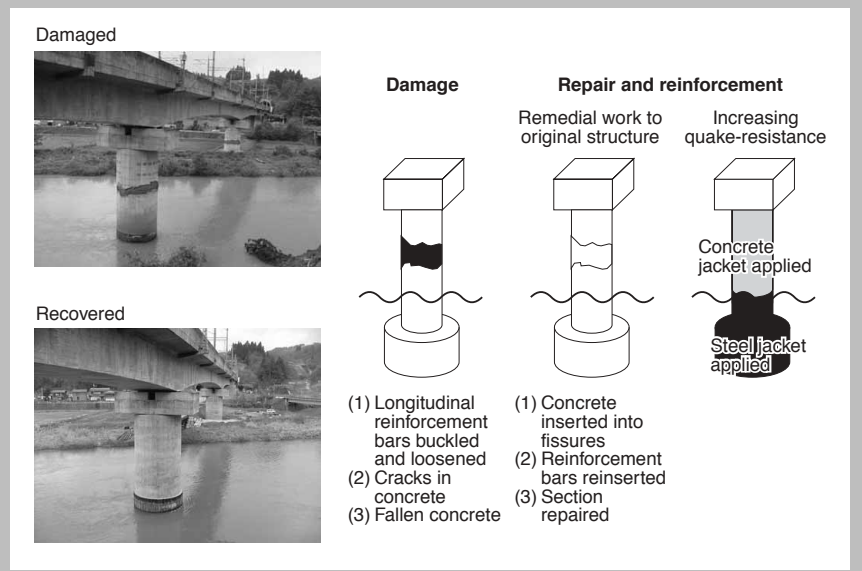
Figure 12 Damage at Uonogawa Bridge

The top left photograph in Figure 12 shows some of the damage to Uonogawa Bridge. Damage to the mid-level of the piers looks extensive, but from a civil engineering viewpoint they were not difficult to repair. The rough drawings show how we plugged the fissures with shotcrete, applied reinforced concrete jackets around the piers above the water

line and steel jackets below it. This made the structure more quake-resistant. The work was a little more difficult than I describe, but you can see the repaired structure in the bottom photograph. In the derailment area, the slabs were basically in good condition, so remedial

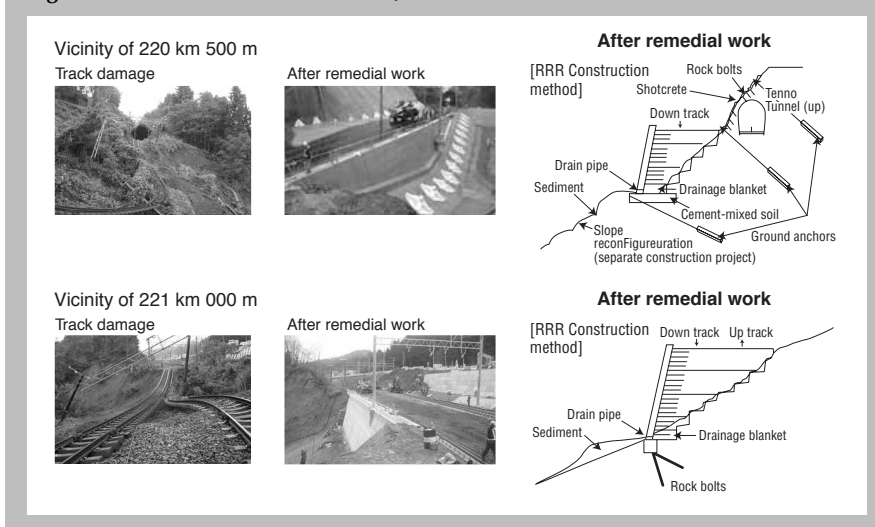
Figure 15 Embankment Failure on Joetsu Line

The photographs on the left of Figure 15 show the slope failure and roadbed collapse on the Joetsu Line next to the Shinano River. The scene of track suspended in mid-air like a rope ladder is typical. The photographs in the centre were taken after the remedial work.

The two diagrams on the right show new retaining walls with earth laid behind them, using the popular Reinforced Railroad with Rigid facing (RRR) construction method, taking into account soil drainage. Thanks to these solid embankments, passenger services are once again operating smoothly.

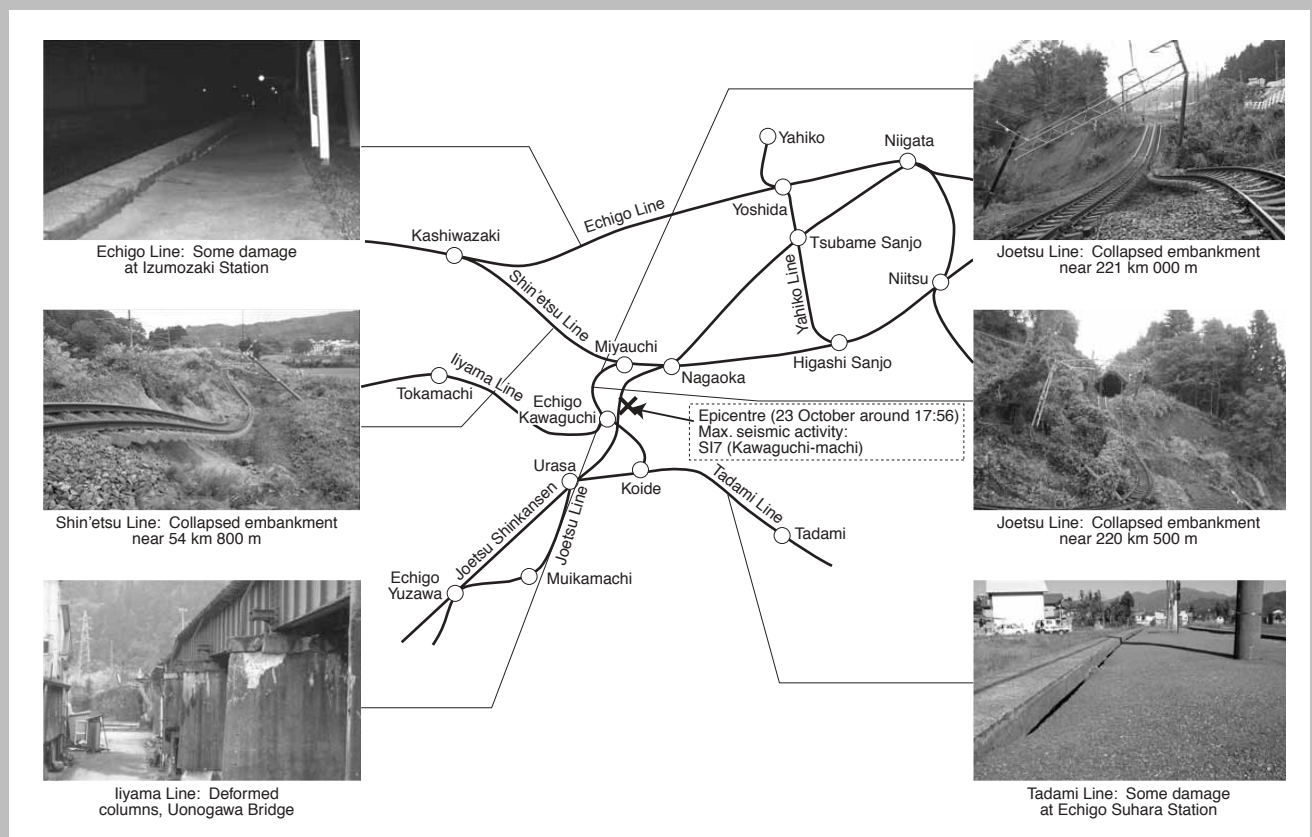
Figure 16 Major Damage to Narrow-gauge Infrastructure

So far, I have discussed only damage to our shinkansen, but our narrow-gauge lines were also badly affected as you can see in Figure 16. Damage to the shinkansen stole much of the limelight from our conventional lines, explaining why not much was reported about them. The top right photograph in Figure 16 shows a line along the Shinano River where the track paralleling the river suffered dramatic damage at cliffs and slopes. Altogether, our narrow-gauge track was damaged at 86 locations. As shown, the tracks were washed out, leaving what appears to be a rope ladder instead of a railway. Quite a few trains were on the affected tracks, but all stopped before or after damaged track, so luckily not one train derailed and no passengers were injured.

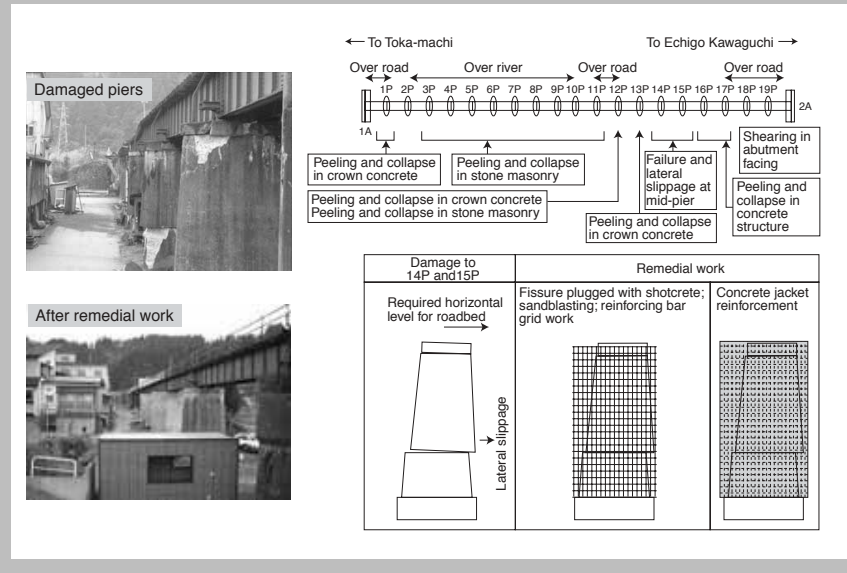
Figure 18 Infrastructure Damage on Uonogawa Bridge, Iiyama Line

The Uonogawa Bridge on the Iiyama Line (Fig. 18) is quite old and was severely damaged, as the photograph shows. The bridge dates from another era before reinforcing; pier 13P in the foreground experienced considerable failure in its upper section and the next pier (14P) was severed in the middle, because the top section shifted laterally by about 50 cm. This is a textbook failure.

The diagrams at the bottom right show the application of a layer of concrete around the pier, followed by a grid of reinforcing bars around the pier, covered by a concrete jacket. The resulting structure is now stronger than ever. The photograph at the bottom left was taken after completion of the remedial work.

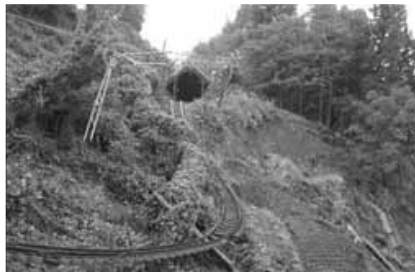
Collapsed embankment (220 km 500 m from base)

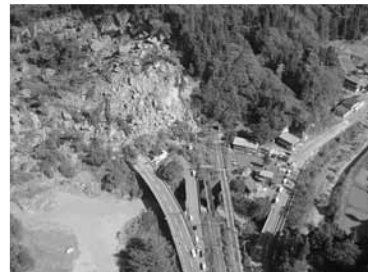
Landslide blocking Enoki Pass Tunnel portal

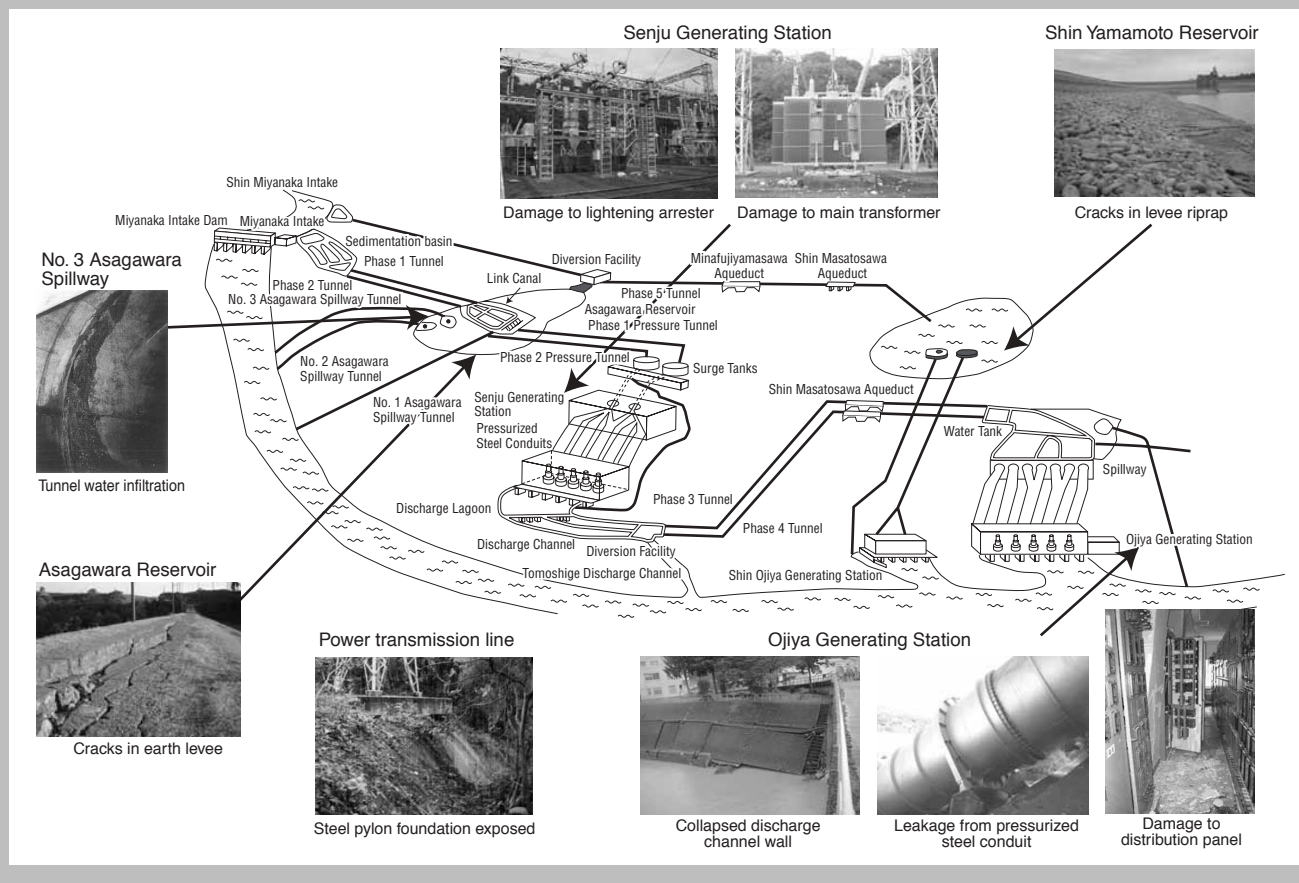
Figure 20 Damage to Shinanogawa Power Plant

Moving away from rail services for a moment, I'd like to discuss the major damage sustained by our Shinanogawa Power Plant (Fig. 20). This hydropower plant has three large storage reservoirs that draw water from the River Shinano to power three generators making the

electricity that we need for morning peak operations. Nearly all these facilities were severely damaged. We have drained the reservoirs and are now examining how best to repair the infrastructure. Unfortunately, the area is now under deep snow and we probably cannot get everything back into full operation before late 2006. However, we need the power and can't wait until then, so from last February we started drawing water directly from the river into the races to generate some power without filling the reservoirs. This is providing about 35% of the plant's normal capacity.
