Damage to JR East from Great East Japan Earthquake and Current Situation

JR East Reconstruction Planning Dept. Facilities Dept. Construction Dept.

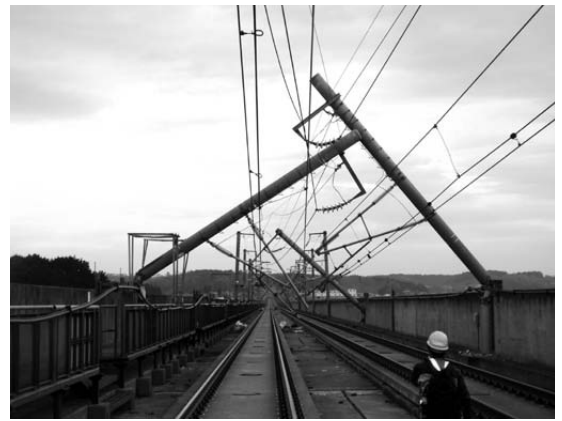
Damage to electric poles

Unlike previous large earthquakes, there was much damage to electric utility poles over a wide area, especially at the connection of poles to viaducts. There was no shear failure due to brittleness, but there was some slight damage, such as flexing failure at the ends of columns and displacement of girders due to damage to bridge supports.

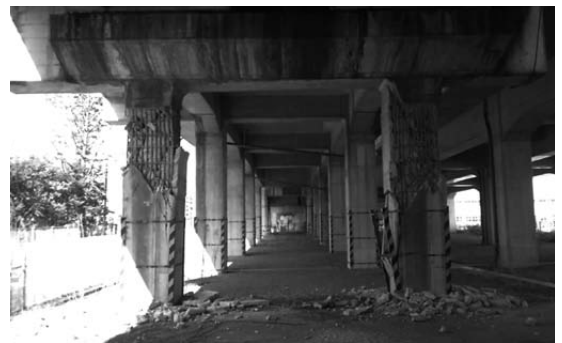
Damage to viaducts

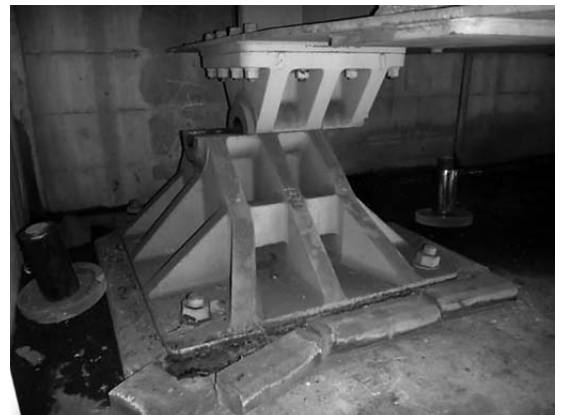
Damage to supports

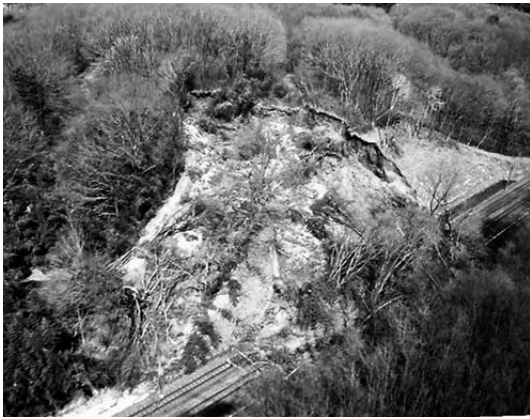
Landslide between Toyohara and Shirasaka on Tohoku main line (JR East)

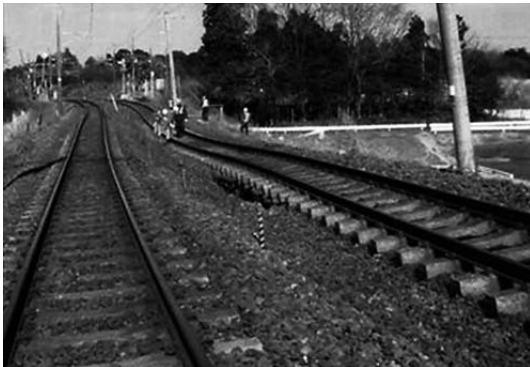
Embankment subsidence between Mito and Katsuta on Joban Line (JR East)

One typical failure was large-scale collapse and deformation of embankments near the offshore epicentre from the Tohoku region. In parts of Greater Tokyo, some buildings subsided due to liquefaction under foundations.

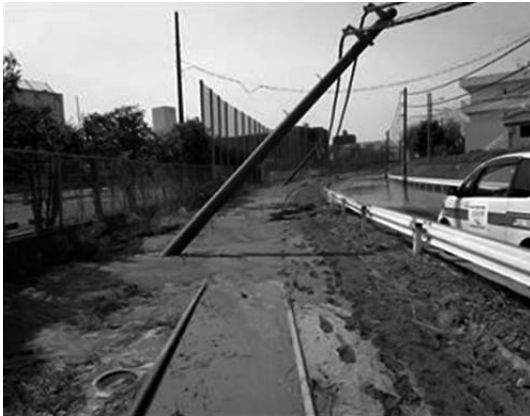
Liquefaction on Echujima Line (JR East)

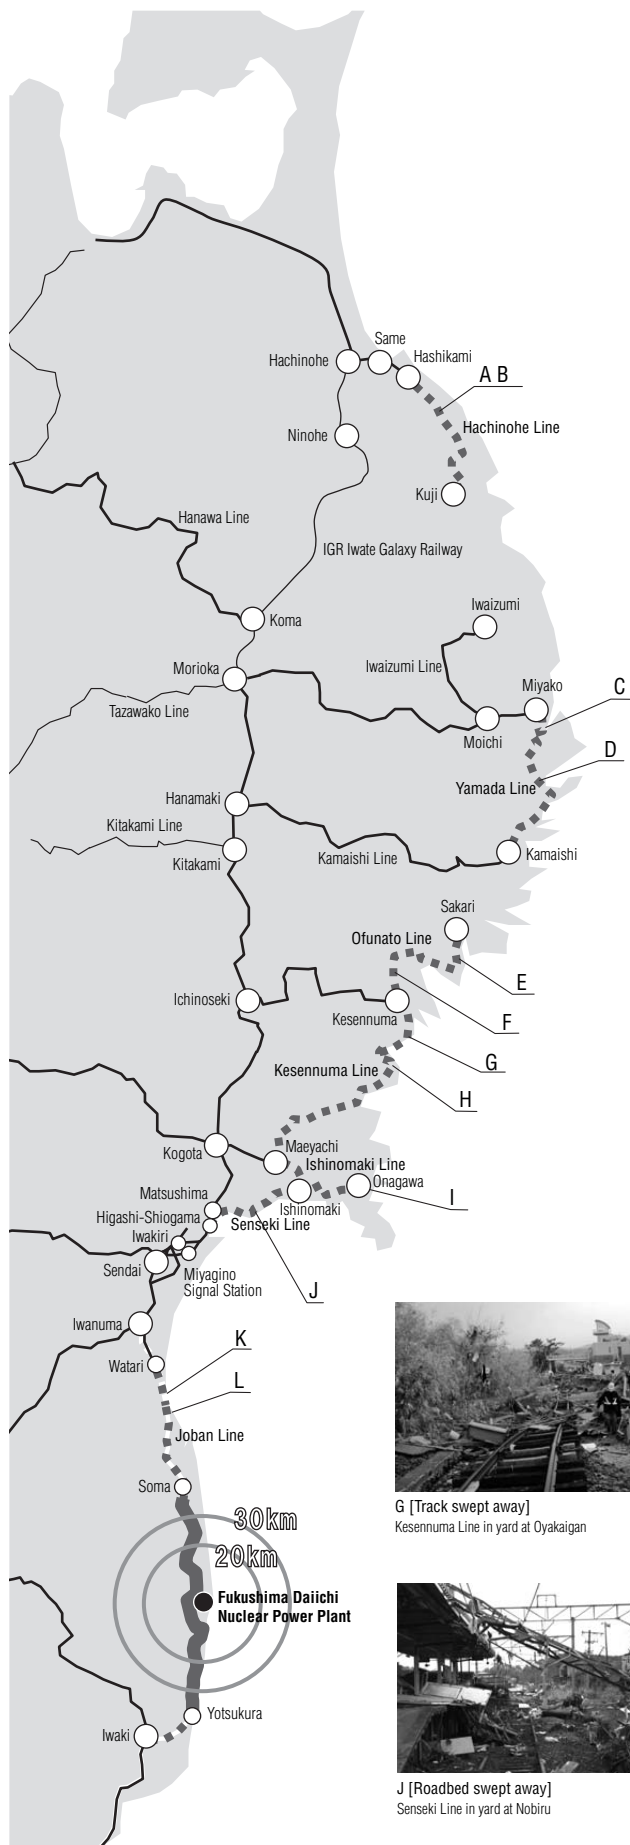
Figure 3 Tsunami Damage to Conventional Lines

A [Bridge girders swept away]
Hachinohe Line between Shukunohe and Rikuchu-Yagi

B [Track swept away]
Hachinohe Line between Shukunohe and Rikuchu-Yagi

C [Track swept away]
Yamada Line between Sokei and Tsugaruishi

D [Bridge girders swept away]
Yamada Line between Rikuchu-Yamada and Oriokasa

E [Track swept away]
Ofunato Line in yard at Hosoura

F [Track swept away]
Ofunato Line between Rikuzen-Yahagi and Takekoma

G [Track swept away]
Kesennuma Line in yard at Oyakaigan

H [Bridge girders swept away]
Kesennuma Line between Rikuzen-Koizumi and Motoyoshi

I [Track swept away]
Ishinomaki Line in yard at Onagawa

J [Roadbed swept away]
Senseki Line in yard at Nobiru

K [Bridge girders swept away]
Joban Line between Shinchi and Sakamoto

L [Track swept away]
Joban Line in yard at Shinchi

JR East suffered major damage on some 325 km of seven coastal lines; stations were swept away and tracks and bridge girders were buried or swept away (Figure 3). Fortunately, there were no fatalities or injuries to train passengers, probably as a result of repeated training including evacuation drills. When crews of trains running near the coast were informed of the tsunami warnings, they stopped the trains and guided passengers to local government evacuation sites.
