Revival of Old Shimbashi Station

Chief Architect, Old Shimbashi Station Project

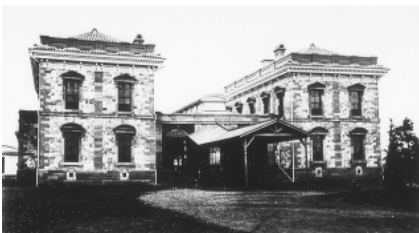
Figure 1

The rebuilt station is based on computerized 3-D analysis of photographs taken just before the opening of the railway (Figs. 1 and 2). Accurate survey data obtained from the rediscovered remains (Fig. 3) were used to determine horizontal measurements, and the dimensions of the dressed stone discovered at the bottom step of the main entrance (Fig. 4) were used to determine vertical measurements. Figures 5a and 5b show the methodology of the 3-D analysis.

Apart from the photographs taken in 1872 (Figs. 1 and 2), there are many later photographs (Fig. 8 shows a different type of carriage porch roofing from Fig. 1) and *ukiyo*e wood-block prints (Fig. 9). However, none gives accurate information about what kinds of stone were actually used and what colour was really presented. Figures 1 and 2 show stones with irregular spots and the excavations revealed that a spotted tuff called *Izu madaraishi* from the Izu peninsula had been used in the platform (Fig. 10a). Our investigation in Shimoda City at the southern tip of Izu found some remaining madaraishi houses (Fig. 10b), but unfortunately, quarrying had stopped many years ago. As a result, we were forced to use a combination of stones of different origins. One of the most difficult questions was what the central part of the main entrance looked like. The only hint is in Hiroshige's wood-block print (Fig. 9) showing the central opening with an arched top. We adopted the same shape but used a modern design in fair-faced concrete in order to demonstrate that this part is not based on the original design (Figs. 11a and 11b).

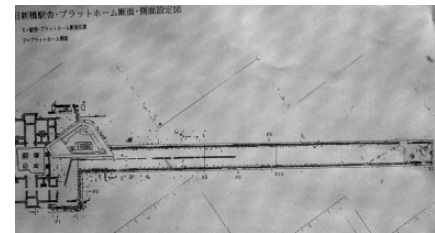
Figure 3

The original platform was 150-m long (Fig. 3), but only 35 m behind the station building was designated as part of the historic site. It had a stone retaining wall on each side and each wall originally had six courses of stones (including cap stones)

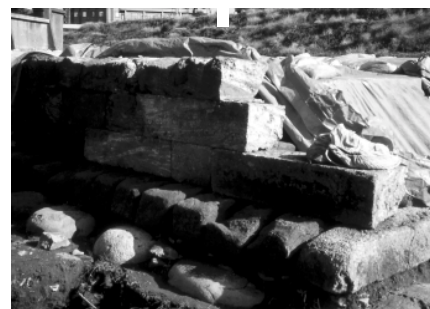
Figure 6

with the top three courses above ground level. Only the lower courses of the platform retaining wall were found (Fig. 6). Figure 7 shows the projection of the walls on the scale drawing of the remains.

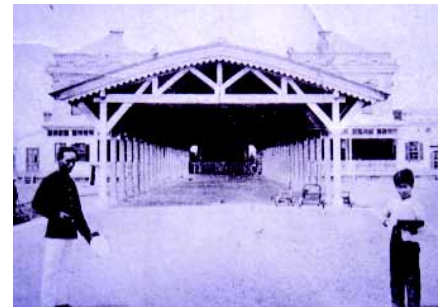
The platform roof was not reconstructed for several reasons and we decided to adopt a modern design. Figure 17 is a period photograph showing the platform roof structure. Figure 18 shows the reproduced platform with modern pillars designed along the lines of the original structure. There are three observation pits outside the building, enabling visitors to look directly at the in-ground remains (Figs. 19a and 19b).

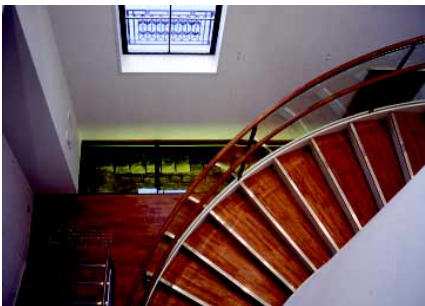
A greater part of the building is leased to a restaurant and the rest is used as the Railway History Exhibition Hall (RHEH) run by EJRCF. Figure 21 shows the RHEH ground floor from the top of the staircase. Visitors can see part of the original foundation through a large floor window. The ground floor also exhibits excavated relics including foreign products used by British engineers who built the first railway in Japan. The upper floor is used for short-term exhibitions on various changing themes. Outside the building next to the platform, 7 m of track is reproduced using authentic double-headed rails forged in England in 1873 (Fig. 22). The reconstructed Old Shimbashi Station is becoming a popular sightseeing spot symbolizing the heart of the redeveloped Shiodome area. ■
