# Aiming at World-leading Maintenance Technology

Hiroaki Inazu

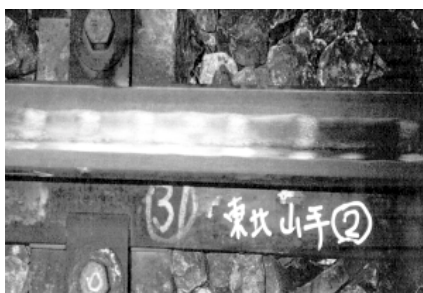
Photo 1: Corrugation wear along rolling surface of rail head (JR East)

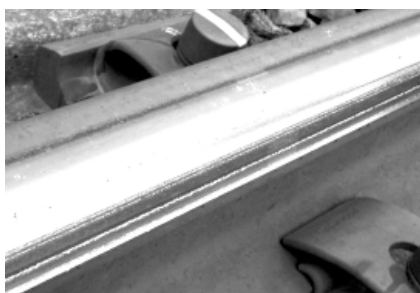
Photo 2: Wear on inside edge of outside rail on curve (JR East)

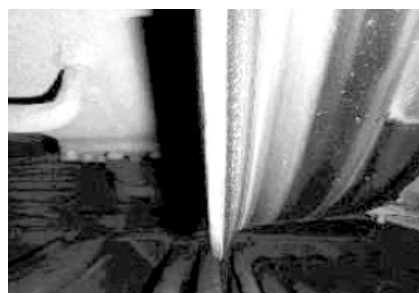
Photo 3: Rectangular wear at inside arc profile of wheel flange (JR East)

The point of contact between the wheel and rail has been a fundamental issue in all previous railway work but there are still a number of major issues that remain to be tackled. A good example is wheel squeal that occurs on sharply curved sections of track due to the contact surfaces between the wheels and rails. Moreover, corrugation along the rolling surface of the rail head (Photo 1) have a major negative impact on passenger ride comfort as well as on rail and carriage maintenance. Other examples are wear occurring on the inside edge of the outside rail on a curve (Photo 2), and heavy wear causing a change in the profile of the inside arc of wheel flange (Photo 3). Another example is fatigue-

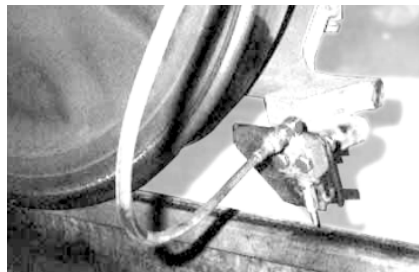
Photo 5: Bogie-mounted greasing mechanism (JR East)

On the other hand, for the outer rail, a greasing mechanism installed on the ground lubricates the inside edge of the rail while another greasing mechanism mounted on the bogie (Photo 5) of the carriage lubricates the inside wheel flange each time a train passes through the curve by spraying lubricant onto the face of the flange running along the inside of the outer rail. In this case too, there are problems with contaminants such as grit sticking to the lubricated rail as well as problems with wheel slip, etc. The new lubricant developed for this purpose is

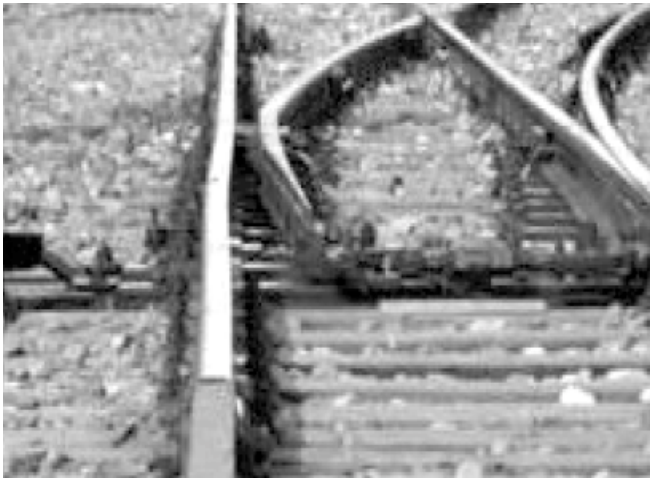
Photo 8: Deformed main rail next to switch tongue rail

The direction of a train passing through points is controlled by the movement of the tongue rails and the structure can be extremely complex, which is a weak point in these types of large ground infrastructure. Certain points error can result from poor mating between the tongue rail and main rail due to deformation like that shown in Photo 8.
