Preparing for Major Earthquakes

Norimichi Kumagai

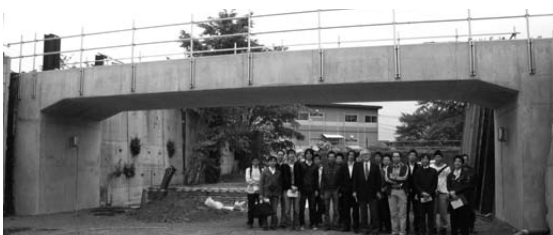
Figure 8 Construction Process and Experimental Bridge

In the integral bridge with geosynthetic-reinforced soil (RRR-GRS), the bridge frame is built after the embankment is constructed.

Experimental bridge at RTRI

The weak points of bridges in earthquakes and tsunamis are the bridge girder supports and the embankments, which are easily swept away. The geosynthetic-reinforced soil (GRS) integral bridge overcomes these weaknesses by bonding bridge girders, facings, and embankments into a single structure using concrete (Figure 8). These structures have double the seismic resistance of conventional structures.

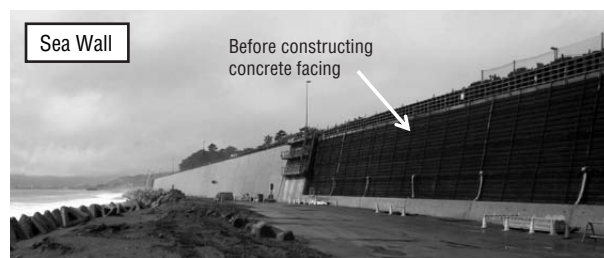
Figure 9 Reinforced Soil Wall and Application for Seawall

The Reinforced Railroad with Rigid Facing-Method (RRR) has proven high seismic performance in the Great Hanshin Earthquake. In 2011, RRR was used for reconstruction of damaged sea walls.

JR Kobe line affected by Great Hanshin Earthquake in 1995

Sea Wall

Before constructing concrete facing

This sea wall was damaged by a typhoon in July 2007.

Conventional embankments have low resistance to shaking, erosion, and flooding in large earthquakes and tsunamis. Moreover, large soil volumes are needed to build high seawalls. To overcome these problems, RTRI developed the Reinforced Railroad/Road with Rigid Facing (RRR) construction method in which reinforcing material is layered in the embankment and covered by a nearly vertical concrete facing as shown in Figure 9. Such structures remained undamaged in the Great Hanshin Earthquake. The method could be applied to seawalls, and we plan to verify its resistance to large tsunamis in the future.

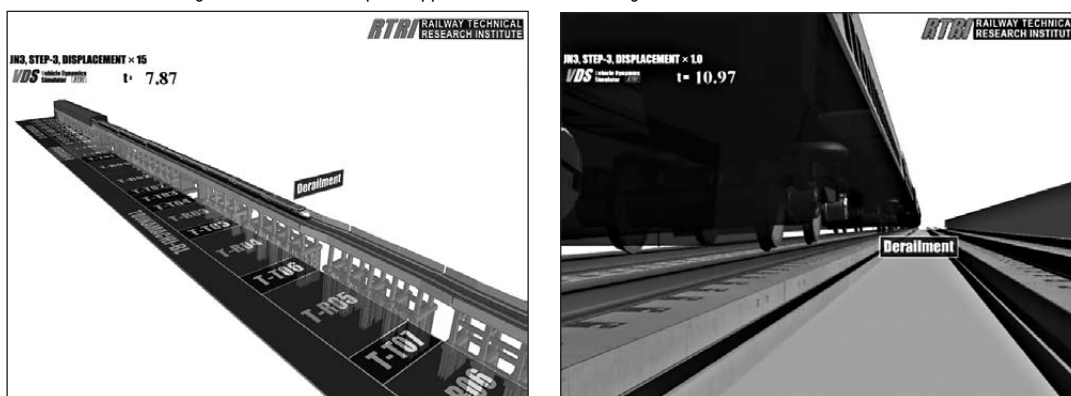
Figure 15 Simulation of Train Motion on Railway Long-Span Bridges during Earthquake

Seismic wave of Mid Niigata Prefecture Earthquake applied to viaducts and bridges

To assess the safety of shinkansen rolling stock running on various structures, previous actual seismic vibrations are used as simulation input waves. For example, inputting the ground seismic waves observed during the Mid Niigata Prefecture Earthquake recreated the behaviour when the shinkansen derailed (Figure 15). In this test, the rolling stock behaviour included numerical simulation of the effects of rail angular bending at structural boundaries. At large-scale seismic motion, general simulation to analyze the behaviour of wayside equipment from the ground to the track surface and the behaviour of the rolling stock is very effective in setting and assessing measures to secure safe running.
