# Preservation and Restoration of Tokyo Station Marunouchi Building

Masahiko Nakai

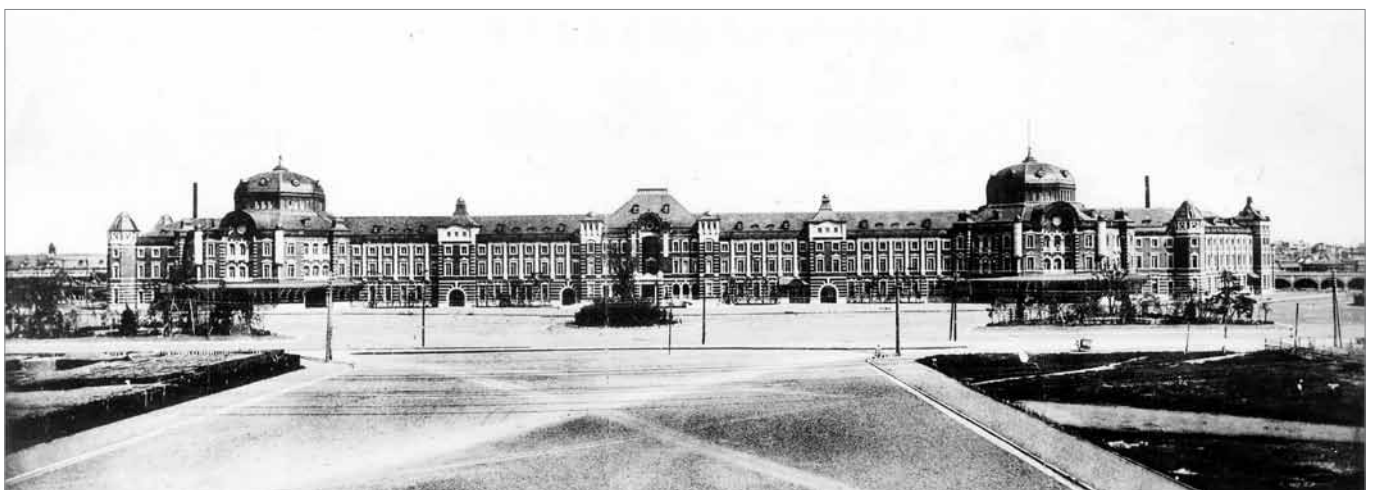
Exterior of Tokyo Station Building at original construction

Construction of the then so-called 'Central Station' started in March 1908, and was completed in December 1914. The station was a long structure facing the Imperial Palace to the west, spanning approximately 335 m north to south with a central section and domes at symmetrical locations to the north and south. It had a floor area of 23,900 m<sup>2</sup> with three floors aboveground and one floor underground in one part. The south dome was for boarding passengers, the north dome was for disembarking passengers, and the central part had an entrance exclusively for use of the Imperial Family. The first floor housed the stationmaster's office, resting and waiting rooms for the Imperial Family, first to third class waiting rooms, restaurants, luggage delivery rooms, and more. The second and third floors had hotel guest rooms and a restaurant in the southern half as well as the Railway Agency offices in the northern half.

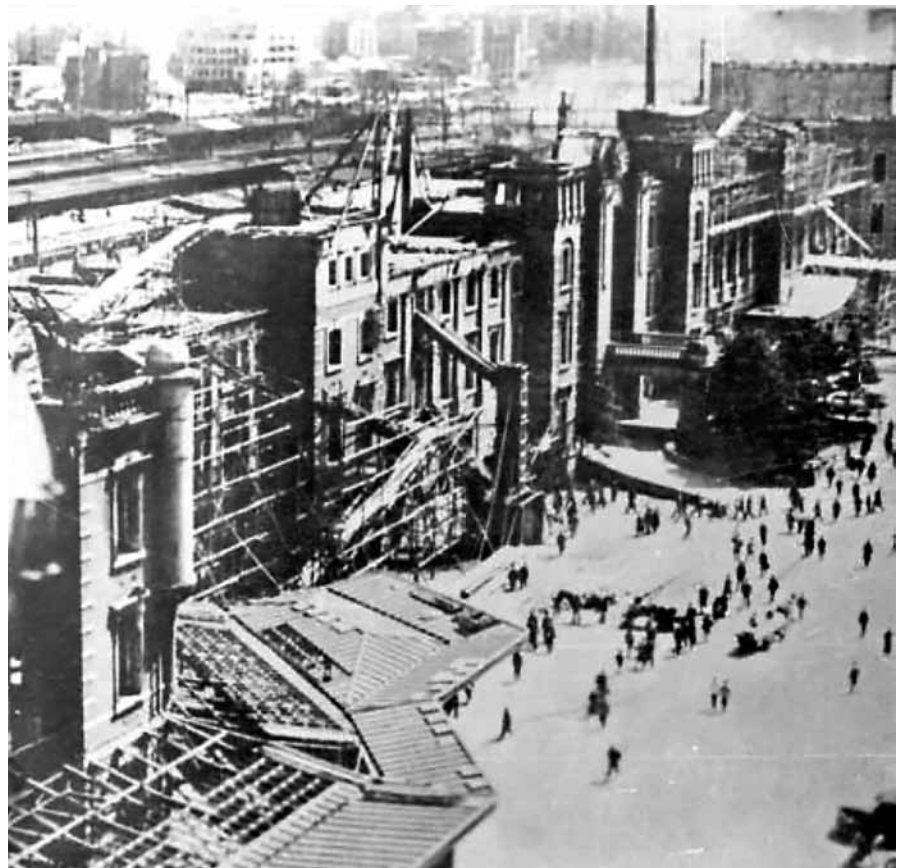
The Great Kanto Earthquake in 1923, caused a tremendous fire and other damage to surrounding buildings, but Tokyo Station stood practically unscathed. While it withstood the earthquake, most of the roof and interior was burned out by air raids in May 1945.

In the postwar restoration work, the structure was modified from the original three floors and round domed roofs to two floors with most of the third floor removed for safety. The domed roofs were changed to an octagonal shape, differing

Damage from bombing in World War II

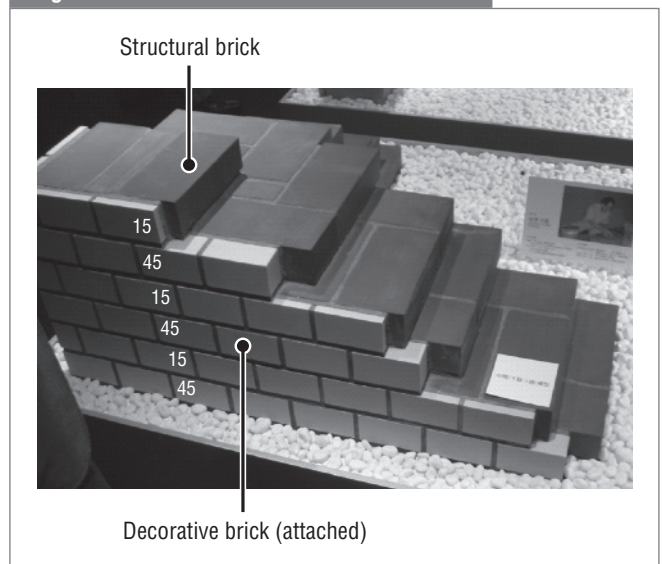
**Figure 2 Structural and Decorative Brick**

The existing station building is a steel-reinforced brick structure. Its outer walls are structural brick overlaid alternately with two types of decorative brick, 45-mm and 15-mm thick (Fig. 2).

To achieve harmony in texture with the preserved part, features of the decorative brick such as smoothness and sharpness needed to be re-created along with colour in restoration of the decorative brick overlay. Test firings and exposure tests were carried out repeatedly. Extremely high-level techniques such as special joints incorporated in the original construction were also recreated.

The frame of the restored third floor is steel-reinforced concrete (SRC), so all the new decorative bricks are 15-mm thick. Moreover, granite and artificial stone accents on the pilasters and window frames have been restored to their original form (Fig. 3).

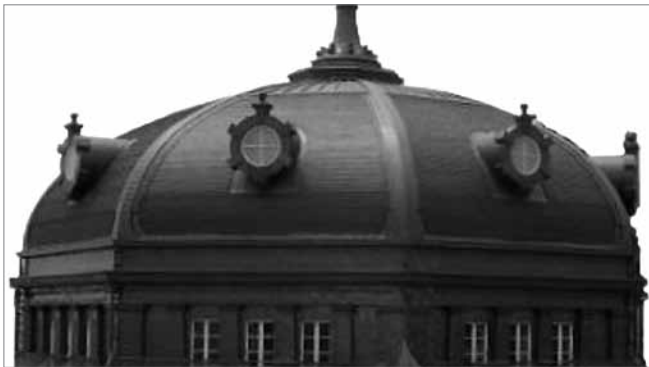
Dome roof

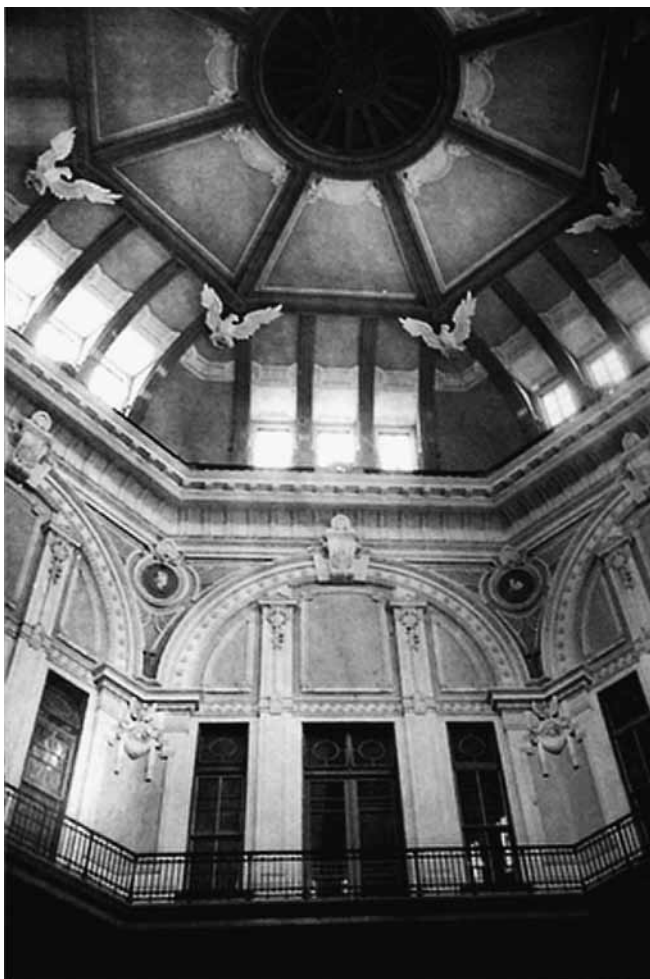
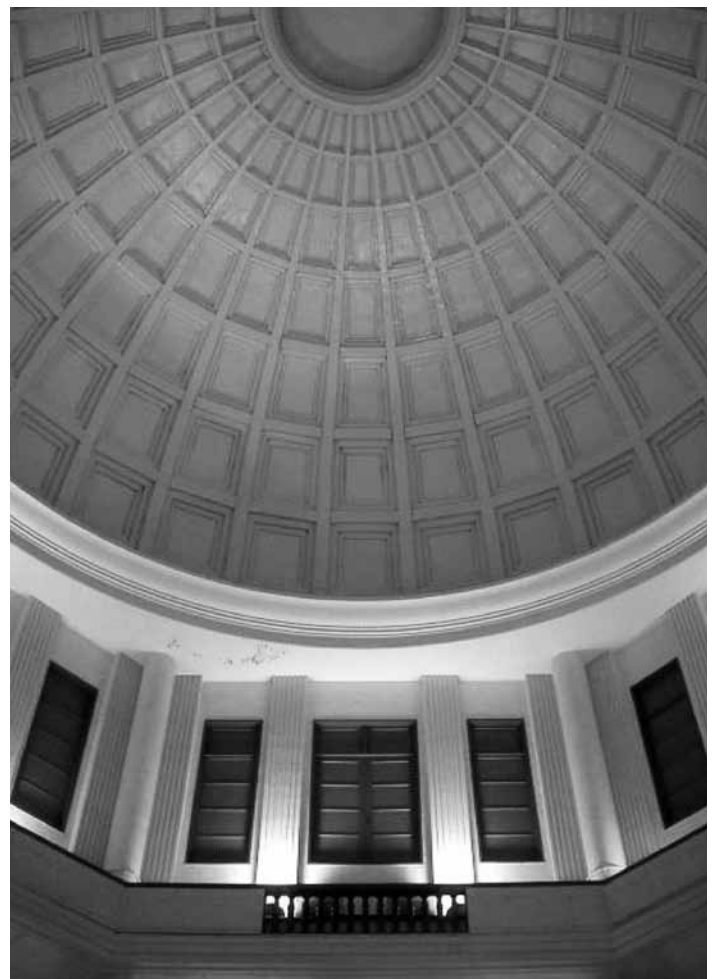
View under dome in 1914 (left) and after postwar reconstruction (right)

The interiors of the north and south domes were the only restored interior parts. The original specifications were estimated from extant photographs, documents, and other literature. The restoration method was studied while surveying the existing conditions, such as part of the original relief still remaining under the duralumin ceiling installed in the postwar reconstruction.

From photographs and surveys, it was discovered that Japanese motifs such as helmets, swords, and zodiac signs were used for the plaster reliefs on the third and fourth floor

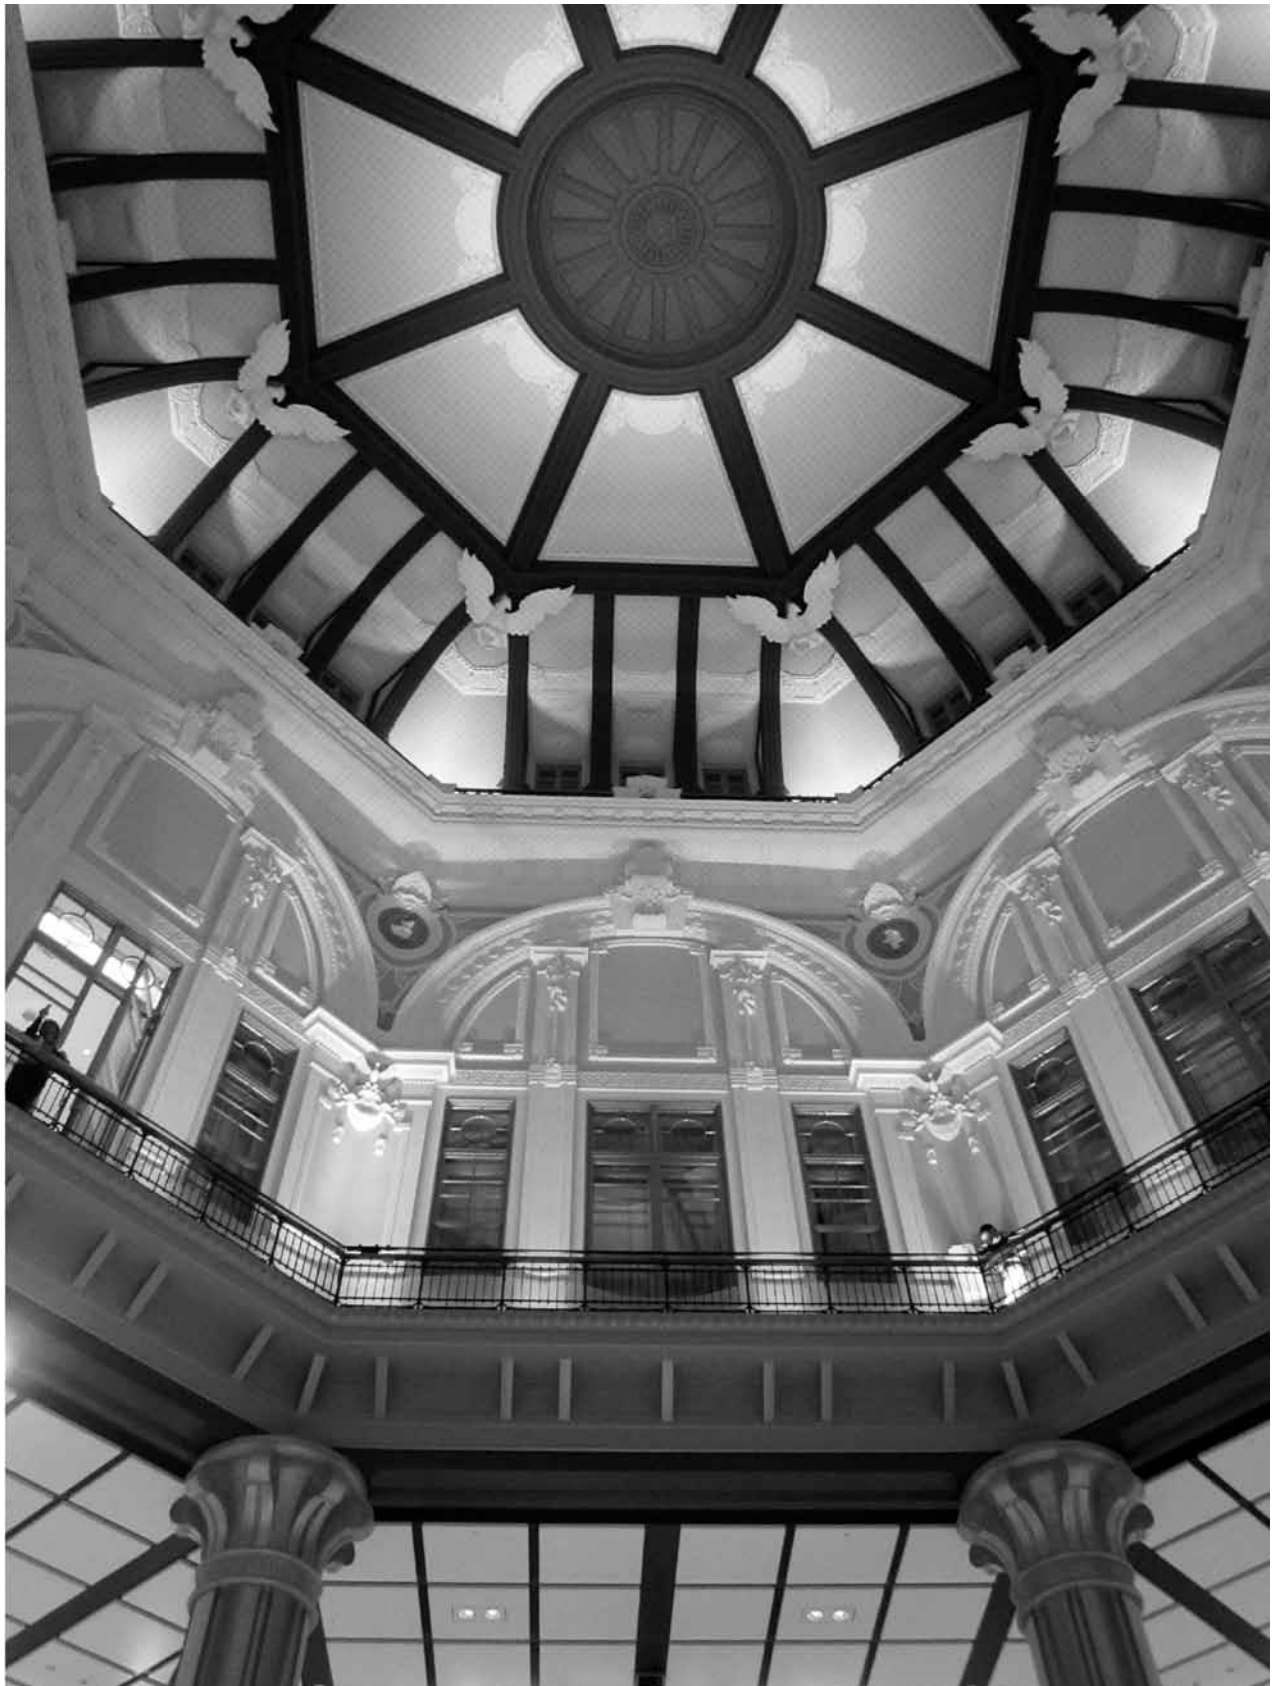
View under dome after 2012 restoration

walls and ceilings. Wooden blocks were also installed on the frames for large reliefs and firmly secured with annealing wire. Documents state that the coloured plaster ceilings

were yellowish and that bright colours were used overall. Such information was gathered and designs identified to restore the interior of the domes lost in the war.

It is worth noting that the remaining original reliefs were very brittle and discoloured due to the effects of fire in the war. However, those that could be preserved were reinforced with chemical agents and refitted.

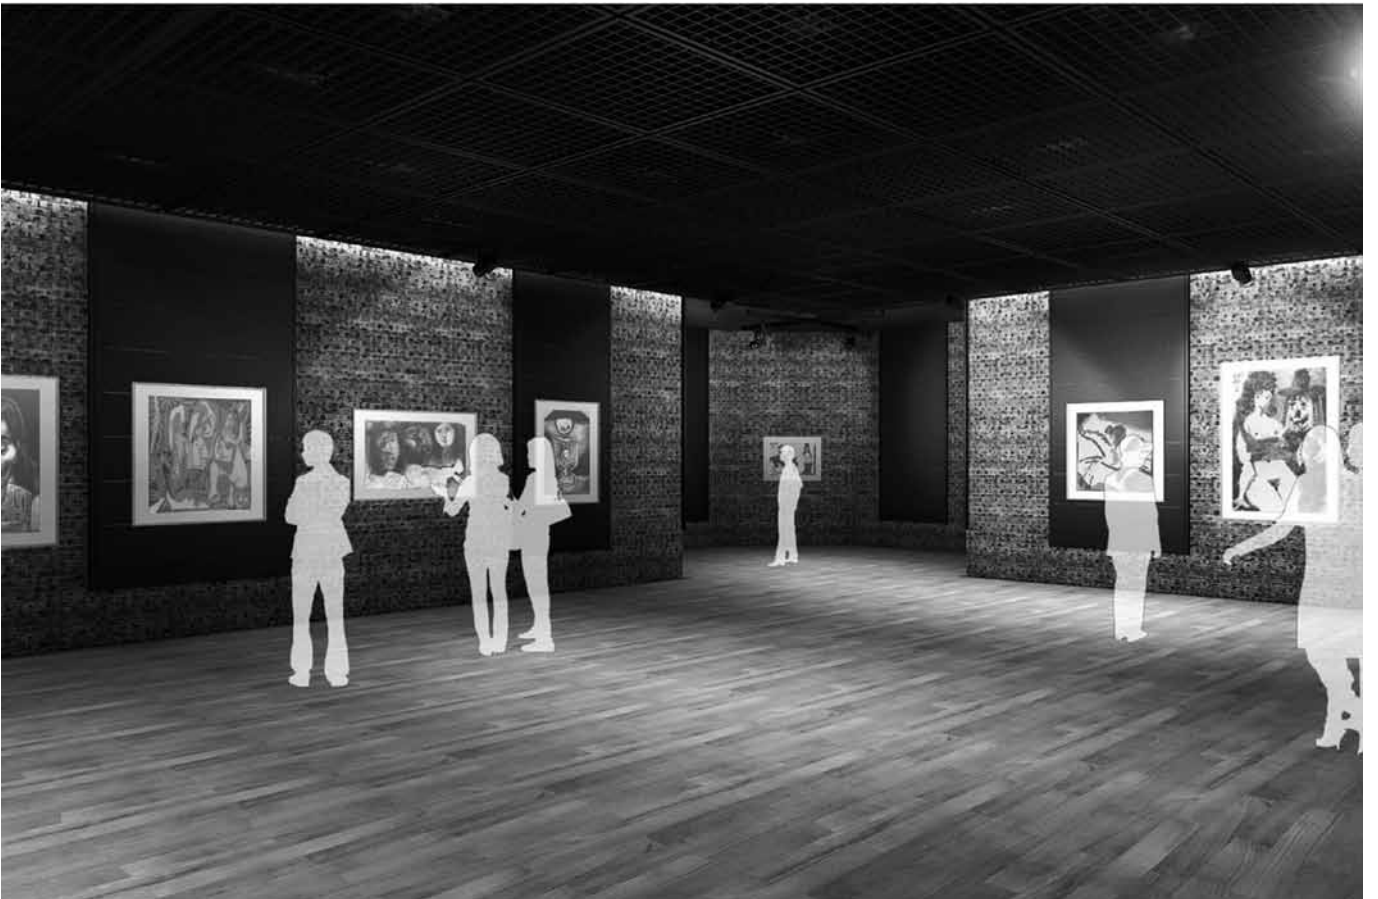
Gallery second floor exhibition room

The Tokyo Station Gallery run by the East Japan Railway Culture Foundation has its entrance hall on the first floor of the north dome. It has exhibition rooms on the second floor where 'history can be felt' by making use of the original brick walls as well as on the new third floor with modern walls. As part of the plan to ensure a smooth flow of visitors past exhibits, an open gallery is situated on the exhibit route where one can view people coming and going in the station and see the restored dome walls.

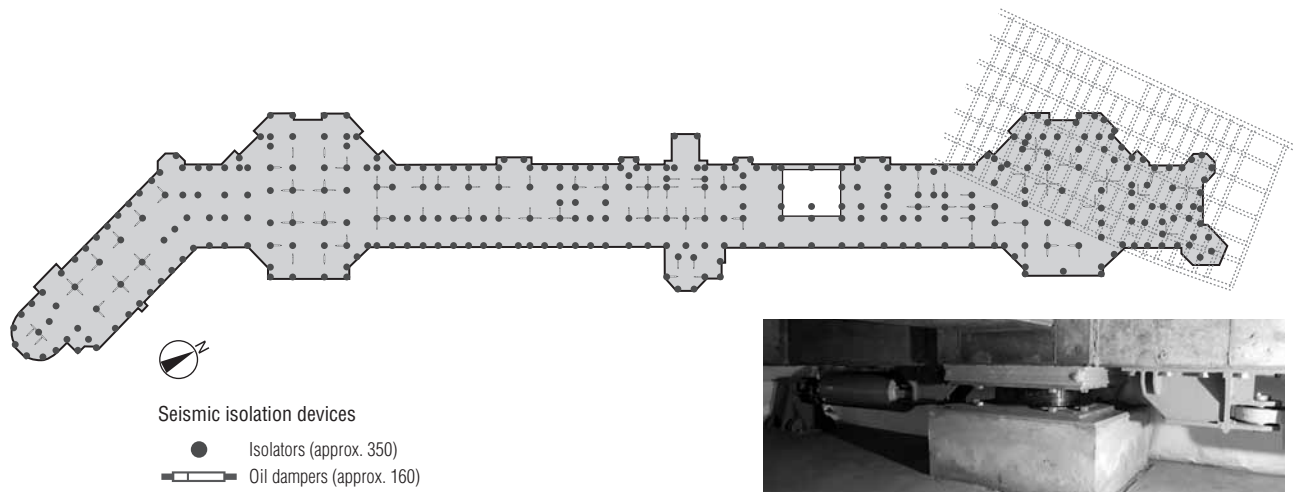
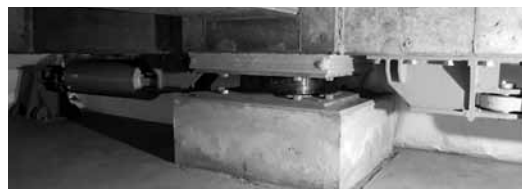
**Figure 4 Placement of Seismic Rubber Isolators and Oil Dampers**

Seismic isolation devices

- Isolators (approx. 350)
- Oil dampers (approx. 160)

Seismic rubber isolators and oil dampers (JR East)

part by inverted construction, adding a seismic isolation layer between the underground and aboveground sections, and transferring the load of the upper structure onto seismic isolation devices (Fig. 4).

In seismically isolating the building, approximately 350 seismic rubber isolators and 160 oil dampers were positioned to hold the seismic isolation layer deformation to about 12 cm relative to the design clearance of 20 cm even in extremely rare massive earthquakes. This performance is high compared to the 30 to 50 cm of general seismically isolated buildings.

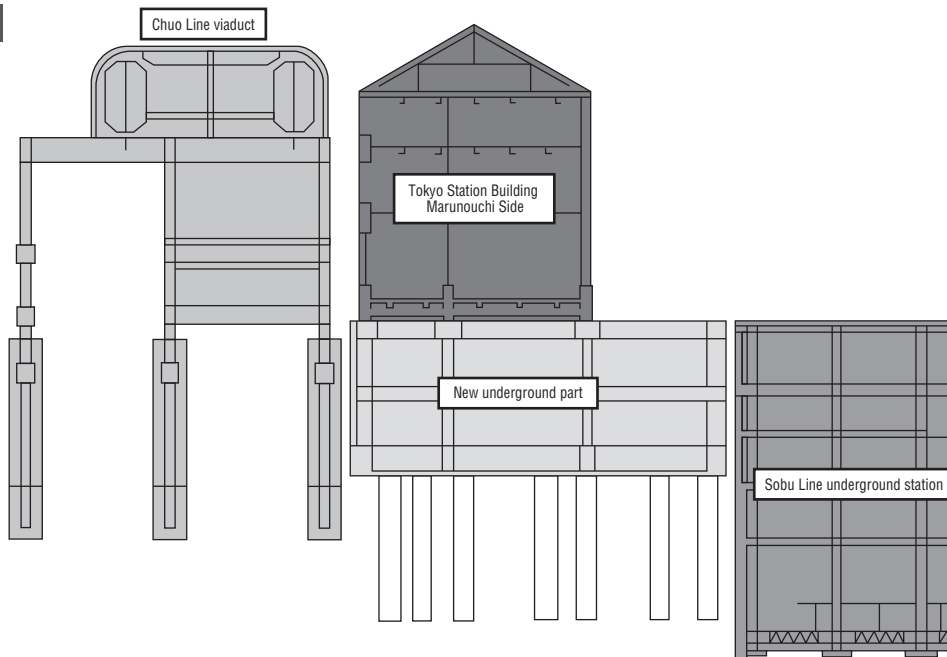
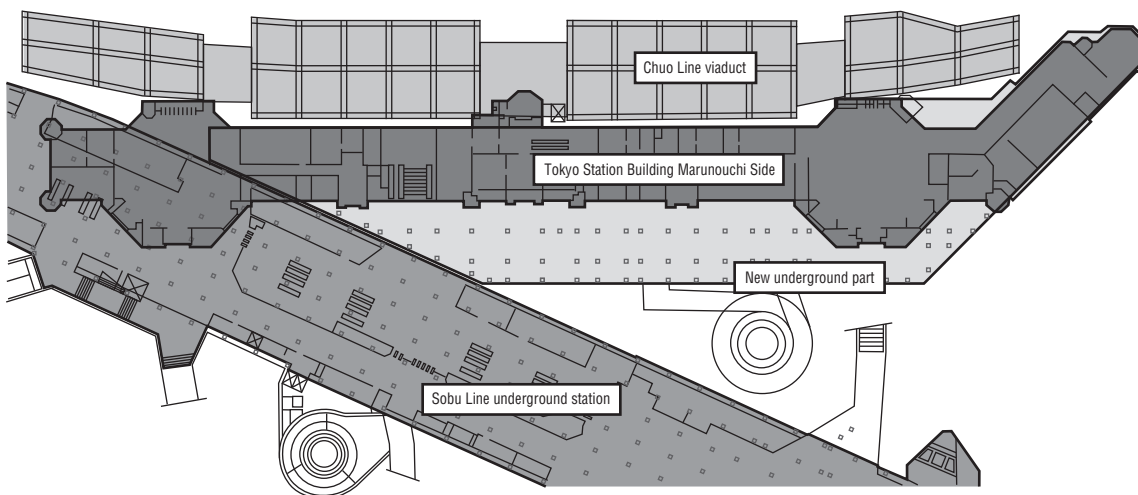
**Figure 5 Facilities around Tokyo Station Marunouchi Building**

**Cross section**

**Plan view**

As shown in Figure 5, the building has a complex relation to nearby structures, such as the viaduct of the Chuo Line located next to the east side, and the building frame of the Sobu Line Tokyo underground platforms directly underneath the north dome. Also, since the seismic isolators span 330 m, many analyses were conducted to verify the aseismic design safety.

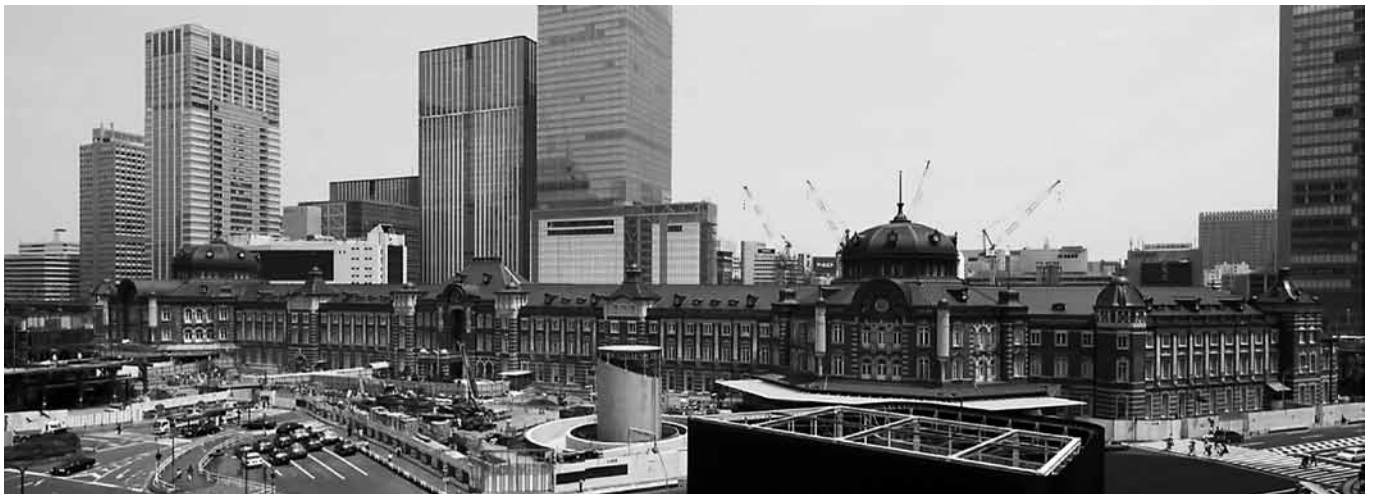
View of restored Tokyo Station Building Marunouchi Side (late August 2012)

the plaza side with granite and artificial stone accents. These were lost in the war, but the walls were all repaired with mortar and painted in brick colour. The lost decorative bricks, pilasters, etc., were all restored on the track side in this reconstruction work.
