Large-scale Renovations of the Civil Engineering Structures along the Tokaido Shinkansen

Masaki Seki

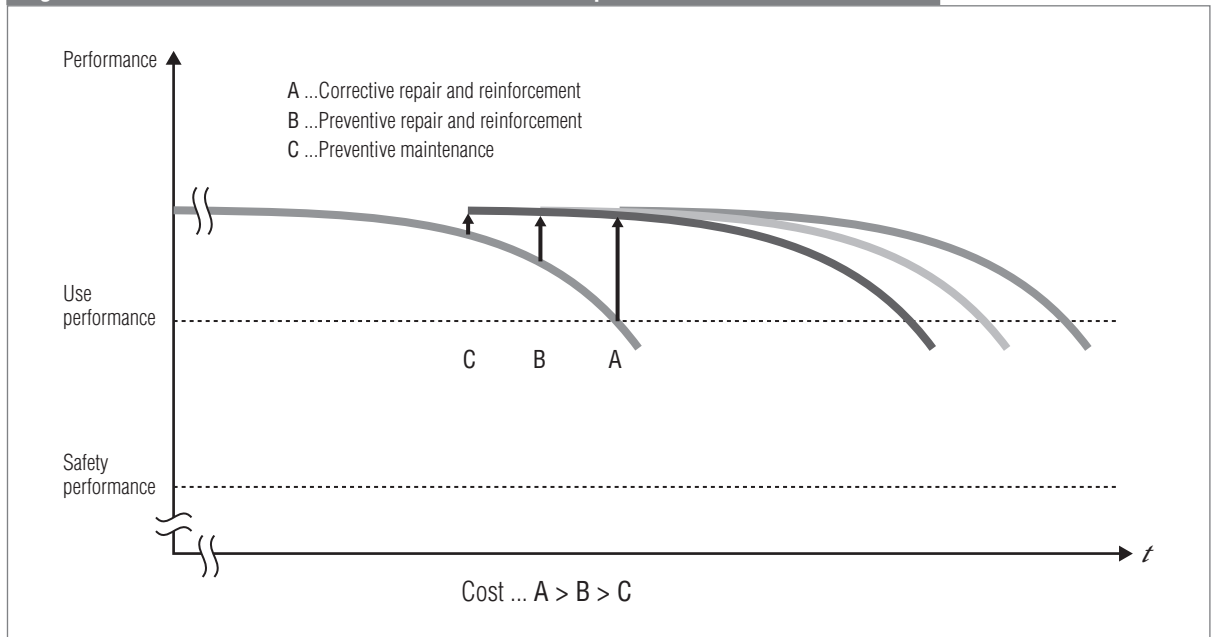
Figure 4 Performance Deterioration over Time and Repair/Reinforcement Methods

The huge damage caused by the 2011 Great East Japan Earthquake was a wake-up call about the importance of infrastructure, so studies on starting the eventual large-scale renovations were brought forward. An application was made in January 2013 to change the reserve (total reserves of ¥350 billion, construction expenses of about ¥730 billion, construction period of 10 years from FY2013 to FY2022) and the application was approved in February. The revised plan calls for a 5-year earlier start of large-scale renovations on the Tokaido Shinkansen using new construction methods from the perspective of preventive maintenance, which inhibits the occurrence of cracks and other deformations while the structure is still sound, keeping overall costs down (Figure 4).

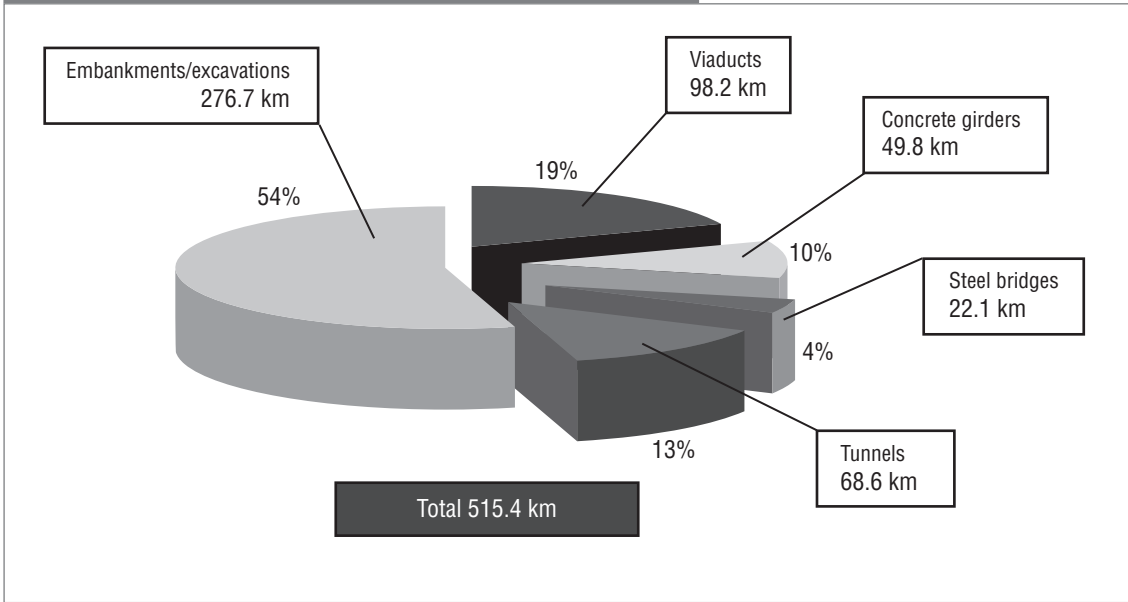
Figure 5 Civil Engineering Structures on Tokaido Shinkansen

The civil engineering structures on the 515.4-km Tokaido Shinkansen comprise 22.1 km of steel bridges (4%), 148.0

km of concrete bridges (viaducts and concrete girders) (29%), 68.6 km of tunnels (13%) and 276.7 km of earthworks (54%) (Figure 5). Of these, large-scale renovation work is to be conducted on steel bridges, concrete bridges, and tunnels, where there are worries about ageing deterioration. The basic method for each type of structure is to implement preventive maintenance at all applicable locations to prevent deterioration and then to continue observation and overall renovation at locations as required.

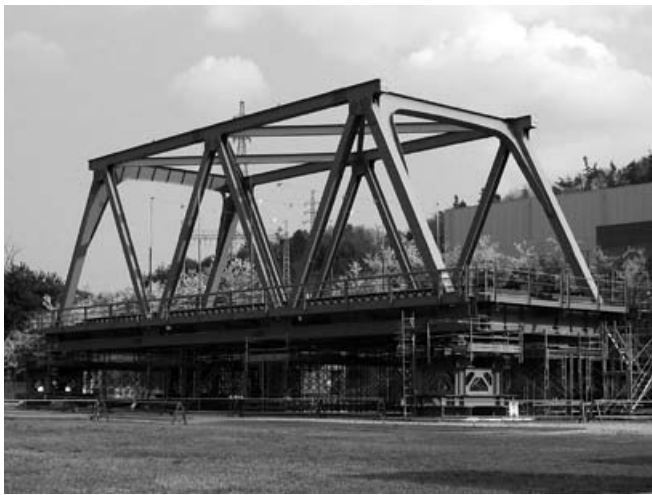
Full-scale truss model (Komaki Research Centre)

from 1964. The proposed remediation was validated by specimen fatigue tests (Figure 9), 3D dynamic running analysis, and dynamic load tests using shinkansen bogies on the full-scale truss model (see photo on p22). The effectiveness of the countermeasures was also confirmed by test construction on an actual shinkansen track.

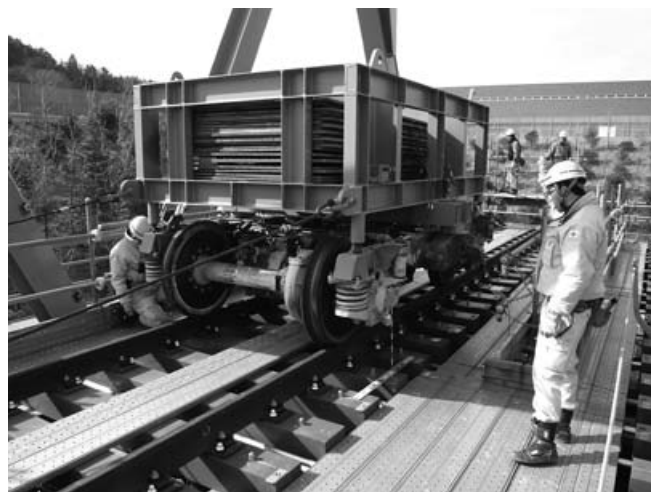
Dynamic load testing with shinkansen bogie

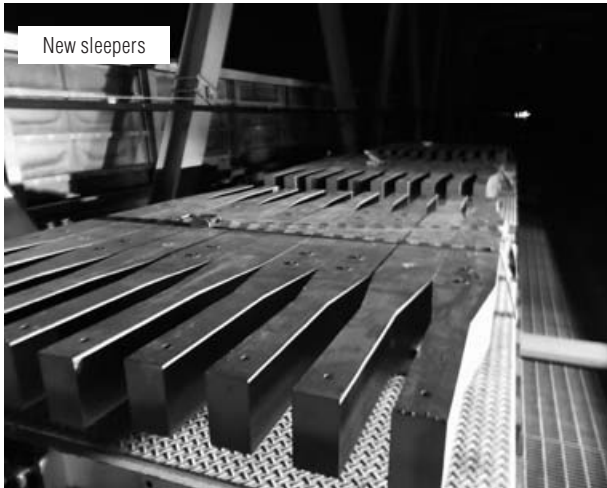
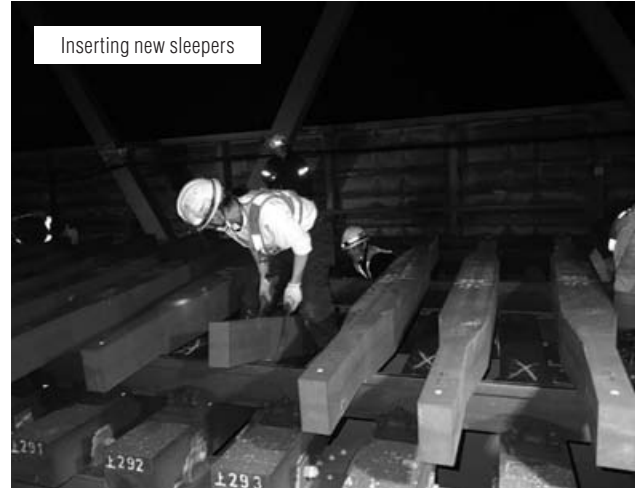
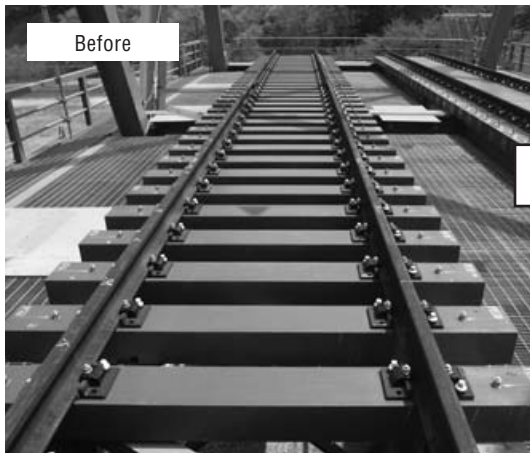
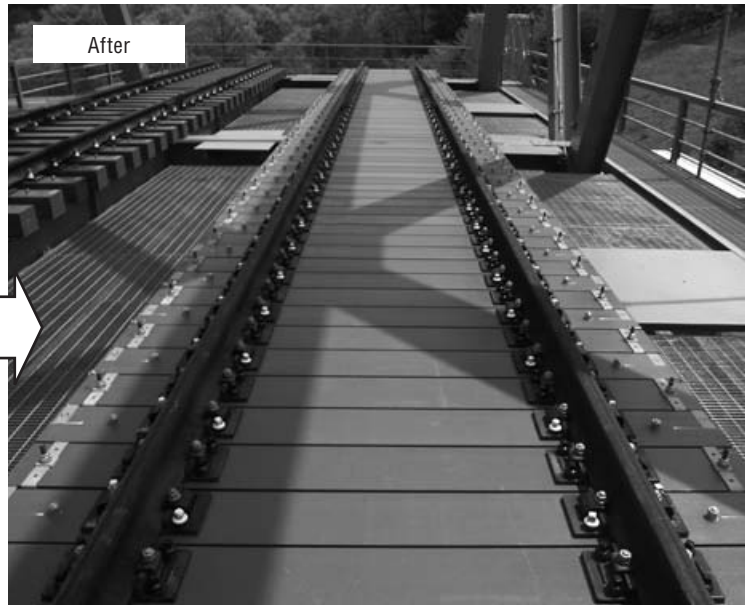
Figure 11 Inserting Sleepers

Rail bending and irregularities can be kept in check by inserting sleepers to make plate-bearing structure and spread the heavy axle loads (Figure 11). Making a very rigid floor system helps cut stress on longitudinal fillet welds. FEM analysis and measurement on actual track before and after construction confirmed reduced stress in fillet welds.
