The Niigata Chuetsu Earthquake —Railway Response and Reconstruction

Masahiko Ogura

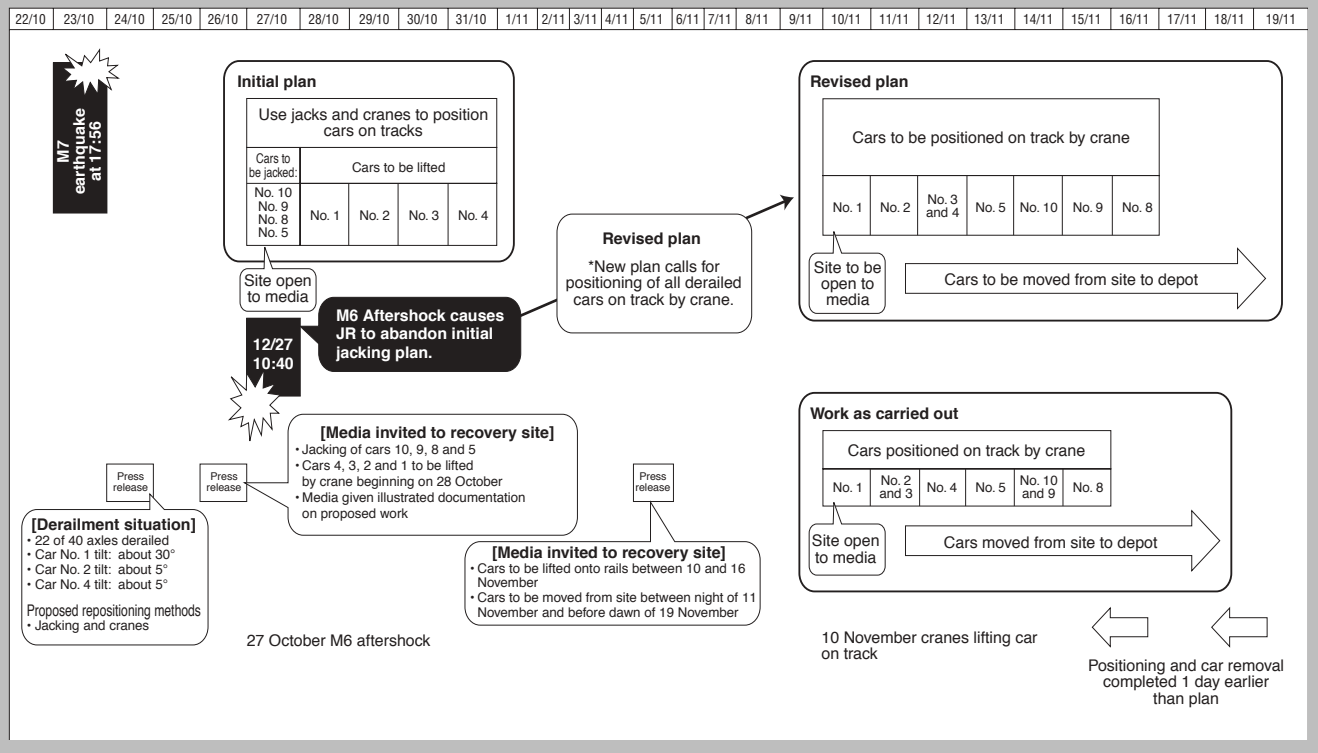
Figure 6 Positioning Cars Back on Track—Plans and Implementation

the 40 axles had derailed either left or right of the track.

As I explain in greater detail later, cars 5, 8, 9 and 10 were slightly affected, cars 6 and 7 were unaffected, and cars 1 through 4 were badly derailed with car 1 shifting a long way towards the Tokyo-bound track and coming to rest at an alarming angle.

Soon after I arrived at the site I realized that our first task would be to get the cars back on the tracks. Figure 6 is a timeline of our efforts to achieve this. On day 4, we began raising some cars. Our initial plan was to use jacks for slightly derailed cars and cranes for cars further off the track. What happened next was widely reported with headlines like 'JR Workers Run for Their Lives.' Just as we were about to start jacking, a violent aftershock of almost magnitude 6 rocked the area. During the jacking preparations, I was on the viaduct giving instructions. There had already been a small aftershock, so I decided to suspend the jacking operation. The site was open to the media and many media people had been on the viaduct, but nearly everyone had gone down to ground level after I suspended work. About the only people left on the viaduct were near the front cars and they were reporters from two media organizations. They were milling around, some with their cameras at the ready, so we shouted to them that the situation was dangerous and that they should get down because the work was suspended. They were slow and were still near the train as the major aftershock struck, explaining why they could take the pictures used as a media scoop. I guess it goes to show that being a slowpoke pays off sometimes. The danger was obvious and it sent a chill down our backs. Without the small warning aftershock, if the violent shock had struck 30 minutes later, many workers

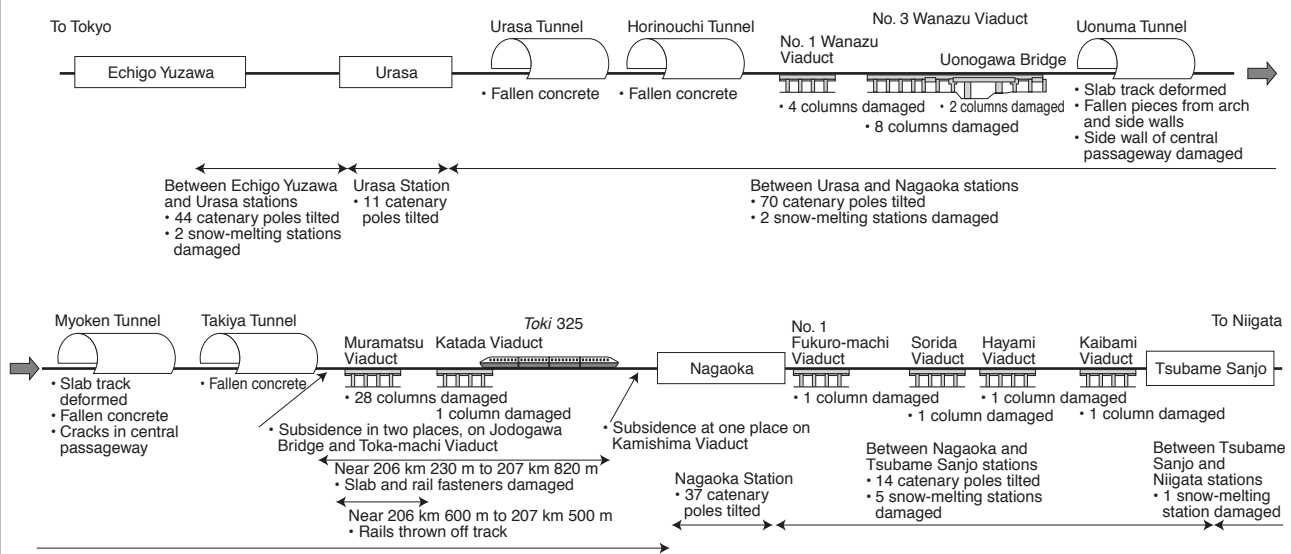
Figure 9 Major Damage to Aboveground Structures—Joetsu Shinkansen

badly damaged. This was certainly a rude awakening!
 Figure 9 shows the track between Echigo Yuzawa, Urusa, Nagaoka and Tsubame

Sanjo stations, with Niigata Station off to the right. The most damaged section was between Urusa and Nagaoka stations, near the epicentre.

Some viaduct columns suffered shear-induced damage, with concrete falling away to expose the reinforcing bars. The Uonogawa Bridge (Fig. 9, bottom right) looked awful with exposed reinforcing bars after concrete broke off about halfway up the columns.

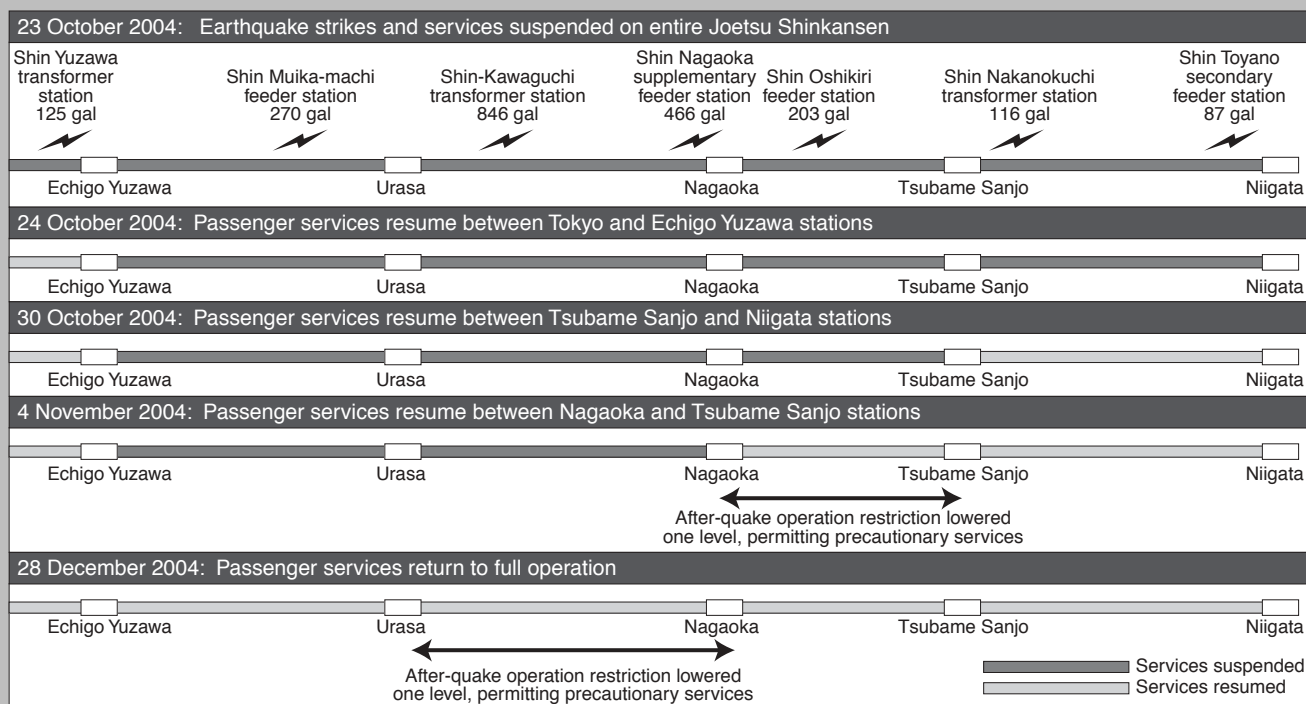
Figure 10 Operation Restart Timeline—Joetsu Shinkansen

We repaired the structures in methodical order. The solid black lines in Figure 10 show track sections where there were no passenger services, while the shaded lines indicate sections with resumed services. Immediately after the earthquake, we suspended services on all sections from before Echigo Yuzawa Station to Niigata Station. The day after the earthquake, trains were running from Echigo Yuzawa from Tokyo.

We continued inspecting each area and repairing the viaducts, making it possible to resume passenger services in one section after another. The Tsubame Sanjo–Niigata section was reopened on 30 October followed by the Nagaoka–Tsubame Sanjo section on 4 November. Excluding the track between Echigo Yuzawa and Nagaoka, we were back in operation just 12 days after the earthquakes. Buses were used to carry passengers between Echigo Yuzawa and Nagaoka until the entire line was made fully operational again on 28 December. Figure 11 shows Uonuma Tunnel with damage in three places. The damage in the middle looks serious, but actually only some 5 to 10 m was badly damaged with about 100 m of the concrete substructure damaged by heaving. Even so, this was unusually serious for a tunnel bored through a mountain and we decided that we would not resume services until we

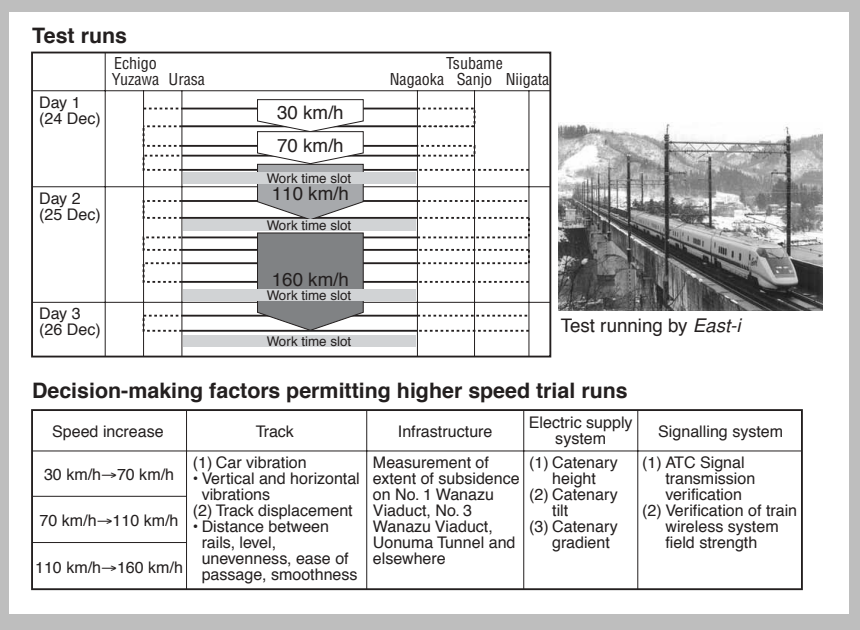
Figure 14 Running Tests on Joetsu Shinkansen between Urasa and Nagaoka

Figure 14 shows the final running tests in late December after most of the construction and remedial work was finished. We began the speed tests on 24 December, starting at about 30 km/h and increasing in increments. The photograph on the right shows an *East-i* track inspection car that used to be nicknamed *Dr Yellow*. On day 1, we began return runs at 30 km/h, then increasing sequentially to 70, 110, and 160 km/h. Most of our attention was focussed on the most damaged track section between Urasa and Nagaoka. Although our test runs went as high as 160 km/h, the first resumed passenger services ran at a reduced speed of 110 km/h over this section. All safety verification tests are generally conducted in this fashion, but we were restricted in this case because of the fast-approaching service resumption date. We managed to finish the running tests in 2.5 days, running back and forth on 26 and 27 December. Then, the first day of full services came on 28 December.

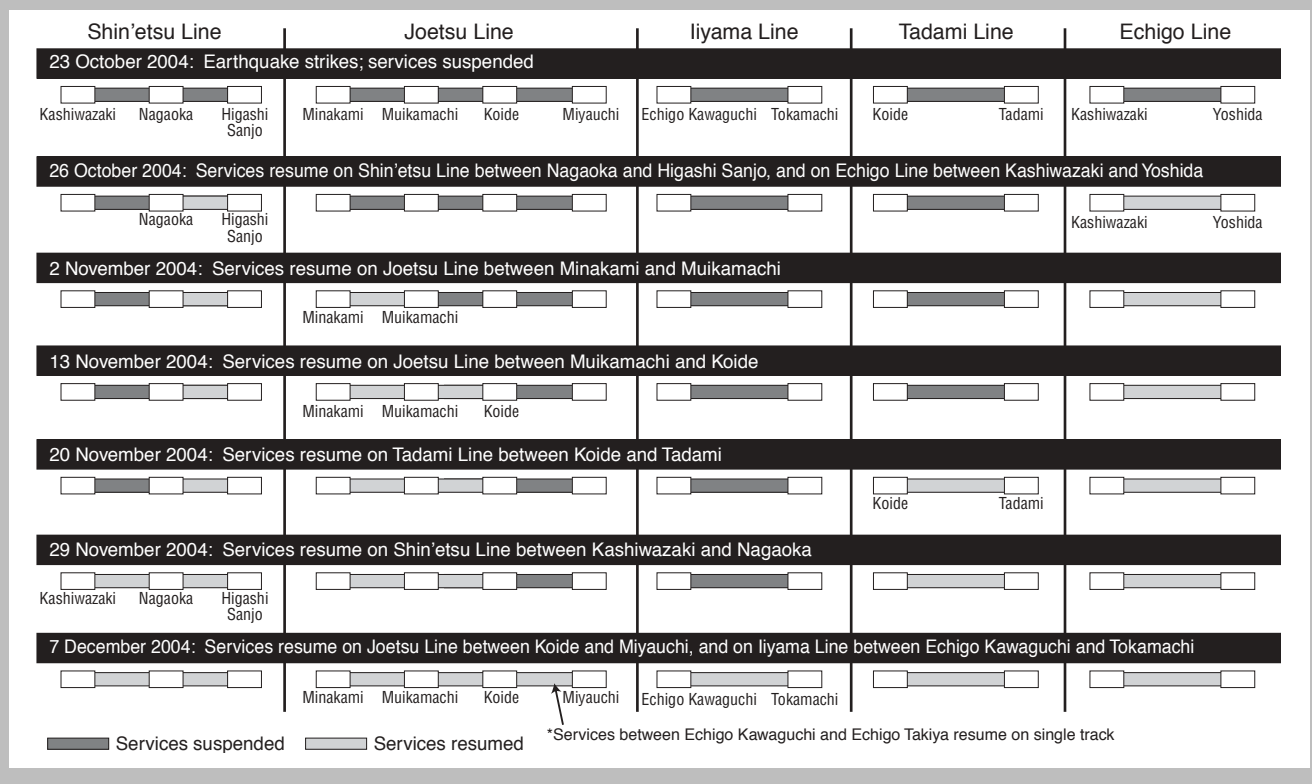
Figure 17 Service Resumption on Narrow-gauge JR Lines

The bottom of Figure 17 shows dates and places of service resumption after remedial work was completed. The columns from left to right show the dates and affected sections of the Shin'etsu, Joetsu, Iiyama, Tadami and Echigo lines. The top bar shows that sections on all five

lines shut on 23 October. Services on the affected sections resumed gradually—the Echigo Line on 26 October, part of the Joetsu Line on 2 November, the Joetsu Line as far as Koide on 13 November, the Tadami Line on 20 November, and the Shin'etsu Line on 29 November. Finally, on 27 December, 1 day before full Joetsu Shinkansen services resumed, trains began running again on affected sections of the Joetsu and Iiyama lines. Somehow we found a way to get all our narrow-gauge lines back in operation.

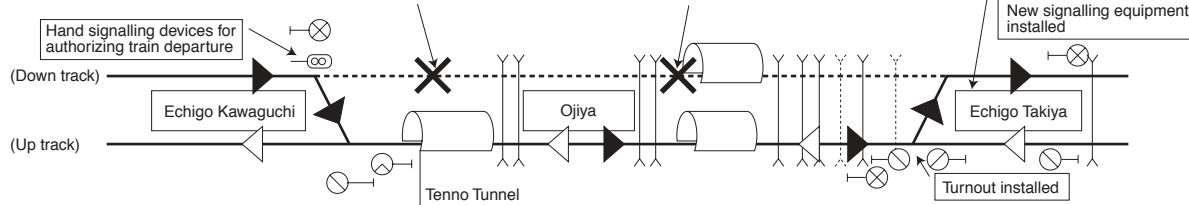
Landslide blocking Enoki Pass Tunnel portal

The last section of our narrow-gauge lines to resume services was between Echigo Kawaguchi and Echigo Takiya stations on the Joetsu Line (Fig. 19) and this section still has only single-track operations. We hope to have both tracks operating by the end of March 2006. The top right aerial shot shows Enoki Pass where a car was buried by a landslide and only a small boy was rescued alive. The photograph shows our two tracks to the right of that road. The tunnel entrance for the down track on the left remains completely blocked by landslide debris. Luckily, the up track to the right of it is free of debris and we are now using it for both up and down services.

- Modifications required for single-track operations
- Tablet/block system for up track
 - Turnout and signalling devices newly installed at Echigo Takiya Station
 - Level crossings modified at 9 locations to accommodate single-track operations
 - Level crossings at 2 of 11 locations in single-track section closed to road traffic for winter—these modifications coordinated with road authorities
