Damage to JR East from Great East Japan Earthquake and Current Situation

JR East Reconstruction Planning Dept. Facilities Dept. Construction Dept.

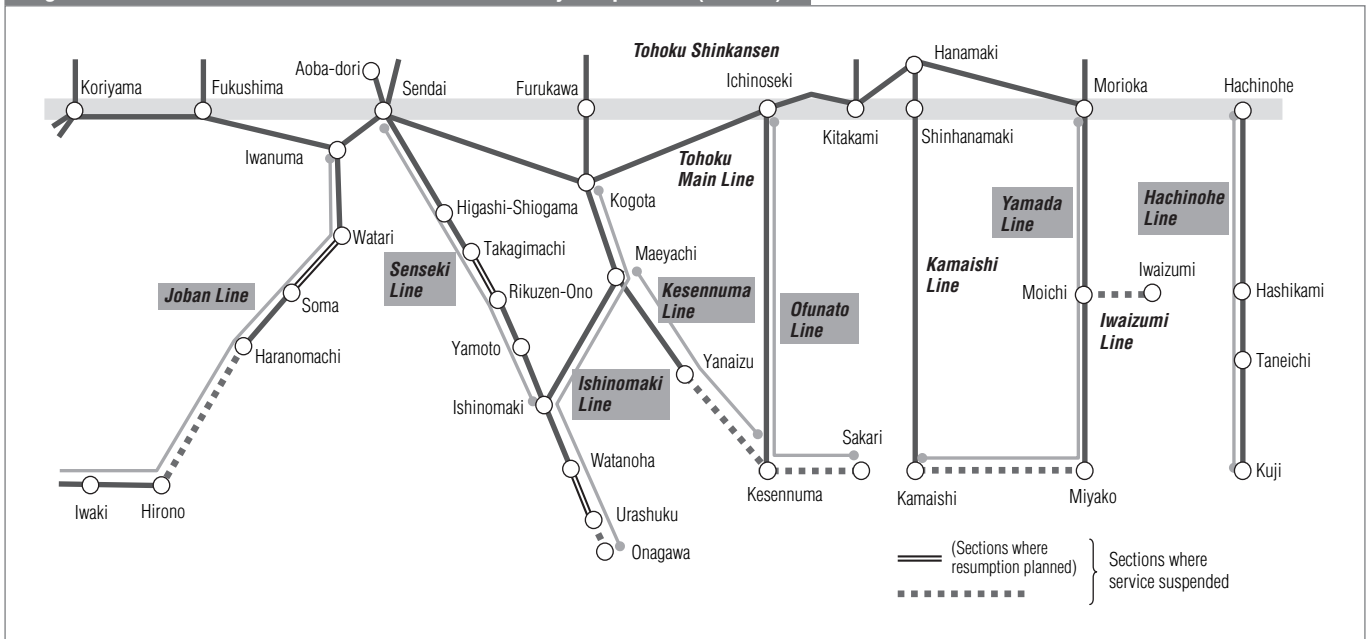
Figure 4 Sections of Lines where Service Currently Suspended (5 June)

In parallel with these discussions, JR East gradually proceeded with construction in sections where safety could be secured and resumed services on the sections shown below (Table 3). As of June 2012, tsunami-damaged sections of coastal lines and sections in the nuclear plant evacuation zone where services are suspended have been reduced from an initial 400 km to about 260 km (Figure 4).
