Maintenance of Railway Structures with Aging Deterioration and Amarube Bridge Reconstruction

Yoshifumi Matsuda

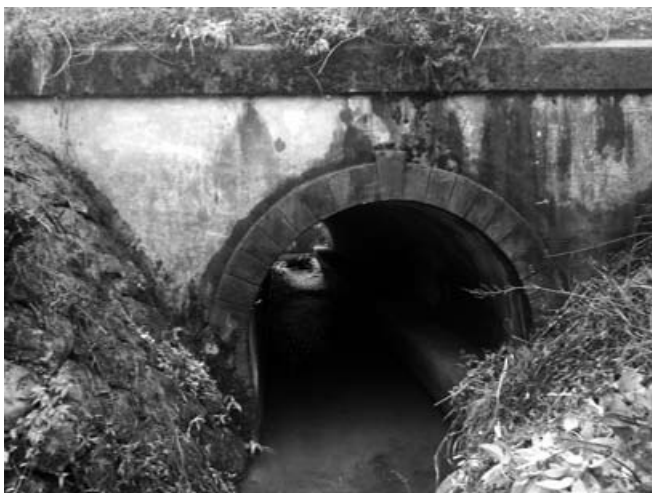
Shimadagawa Bridge, first RC railway bridge in Japan (JR West)

Shimadagawa Bridge (1.83 m) between Yonago and Yasuki on the San'in Line, constructed in 1907, is the oldest railway RC bridge in Japan. It has remained in sound condition with absolutely no repair work at all since the initial construction. In contrast, some RC structures built in the 1970s during the period of rapid economic growth contained insufficiently desalinated beach sand or were otherwise inferior in quality

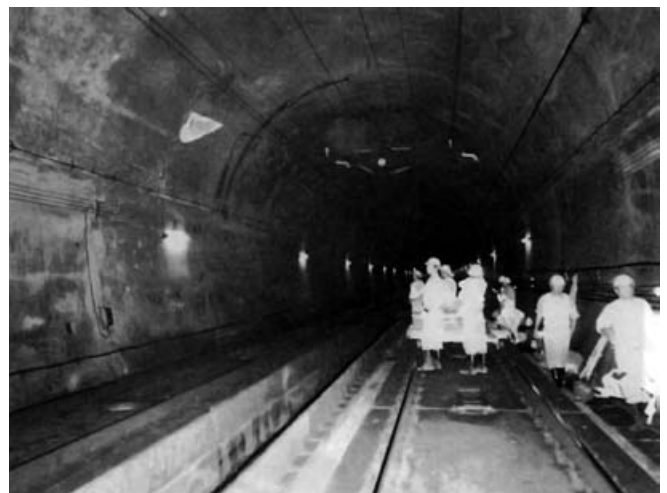
Concrete falls from Fukuoka Tunnel lining of San'yō Shinkansen in 1999 (JR West)

In general, railway structures are designed and constructed for long-term durability, because they cannot be replaced easily; inspection and repair work are done as necessary to ensure structural safety and usability. Construction of the San'yō Shinkansen was completed within a short time period in the 1970s, overcoming difficulties such as inflation and scarcity of building materials due to the oil shock crisis. However, within 30 years of its completion, deformation such as flaking and dropping of cover concrete on some viaducts was apparent. In 1999, concrete blocks weighing about 220 kg fell from the San'yō Shinkansen Fukuoka Tunnel lining, hitting a train. In response, the Committee on Investigation of Tunnel Problems was established immediately by the then Ministry of Transport to study the causes and recommend measures to maintain the soundness of tunnels. The final summary concluded that the causes were:

- Interruptions during concrete placing caused cold joints to grow in the concrete lining.
- Wide-area cracks grew in lining under the cold joints due to vibration of steel supports during concrete placement and/or removal of forms.
- Further vibration and pressure changes caused by

running shinkansen trains caused cracks to develop until the accident occurred.

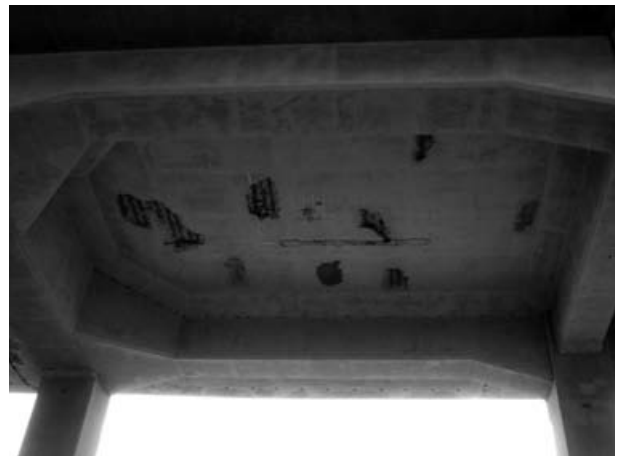
Hammered-off areas under viaduct slab

Routine inspections of RC structures are carried out once every 2 years and special inspections are carried out once every 10 or 20 years. In addition, viaduct inspections are made as necessary to prevent objects falling from structures. The routine general inspection is intended to detect deformation as well as ascertain the soundness of the entire structure. The inspection method is based on visual inspections from the ground, and inspectors update the database for structures where deformations such as cracking and flaking have occurred or are developing. The special general inspection introduced in 2006 aims to improve the accuracy of the soundness determination using a careful close-up visual inspection. Inspections of viaducts targeting sections intersecting or running parallel to roads and over leased sites are conducted to prevent third-party damage as well as to confirm safety. The close-up inspection uses either a vehicle-mounted elevating platform or scaffolding, and deformed concrete is detected by tapping.

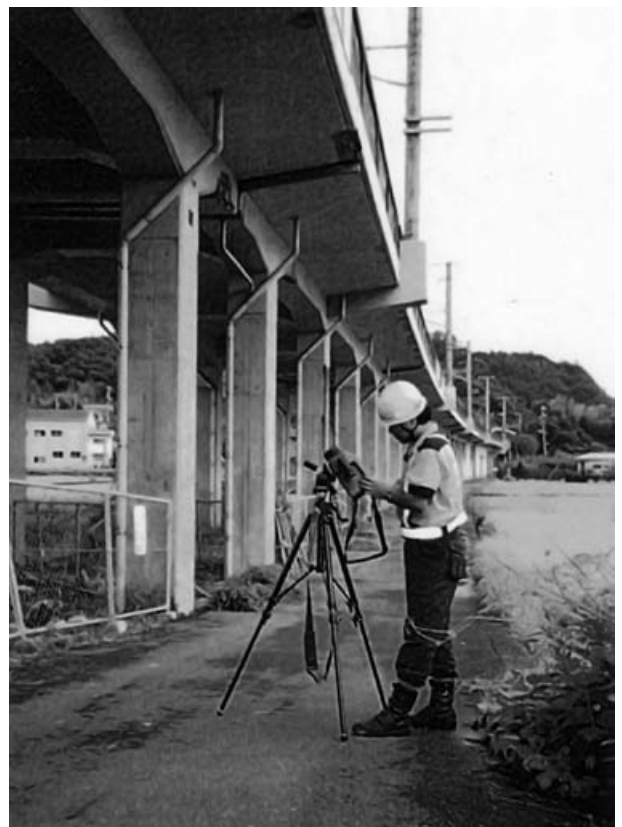
Infrared camera for detecting concrete delaminations

Since 2001, JR West has been working to develop a method for detecting concrete delamination in viaducts from the ground and to improve inspection accuracy using an infrared camera in areas where close-up inspection from elevated platform or scaffolding is difficult. Testing was carried out on San'yo Shinkansen viaducts before wide introduction of infrared cameras to draw-up criteria that established conditions for application, and to create a manual.

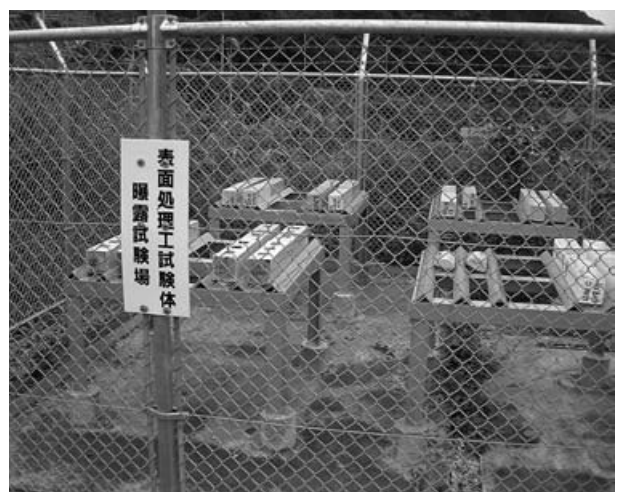
On-site weathering tests of repair materials

in the laboratory could not necessarily be guaranteed at on-site construction work. Therefore, JR West decided to stipulate new testing methods and acceptance criteria using actual viaducts and accept those 'approved materials' that passed testing. There are currently 22 approved materials. The *Repair Work Guidance for Concrete Structures* was established in 2001 to regulate repair work. It describes the materials and procedures for various repair methods used at repair works in an easy-to-understand manner.

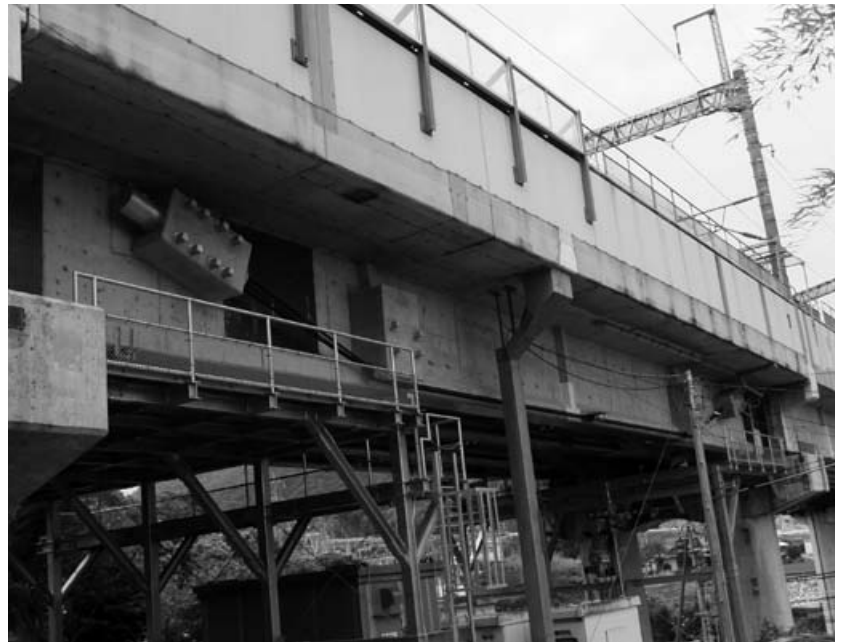
Figure 2 PC External Cable Tension Monitoring System

PC External cable tension monitoring system

Many medium-span bridges on the San'yō Shinkansen used post-tensioned PC structures to reduce noise. In some cases, tendons that were left ungrouted at construction are found at maintenance. Water infiltration around these ungrouted tendons eventually causes corrosion that breaks the wire. To remedy this serious situation, JR West makes repairs by regrouting voids along tendons. However, for post-tensioned PC structures on the San'yō Shinkansen, there is a worry that broken internal cables would cause a decline in functions such as load resistance, running safety, and ride comfort, as well as putting structures out of service for long repair periods. Therefore, an external cable tension monitoring system is being developed (Fig. 2). In this system, an external cable is installed on both sides of the PC structure. As well as detecting internal cable breaks using a sensor to monitor tension changes in the external cable, the external cable also functions as a strengthening

cable if an internal cable breaks. The effectiveness of this external cable tension monitoring system was verified by experiments and analyses using test specimens, and 2012 marked its application to actual structures.

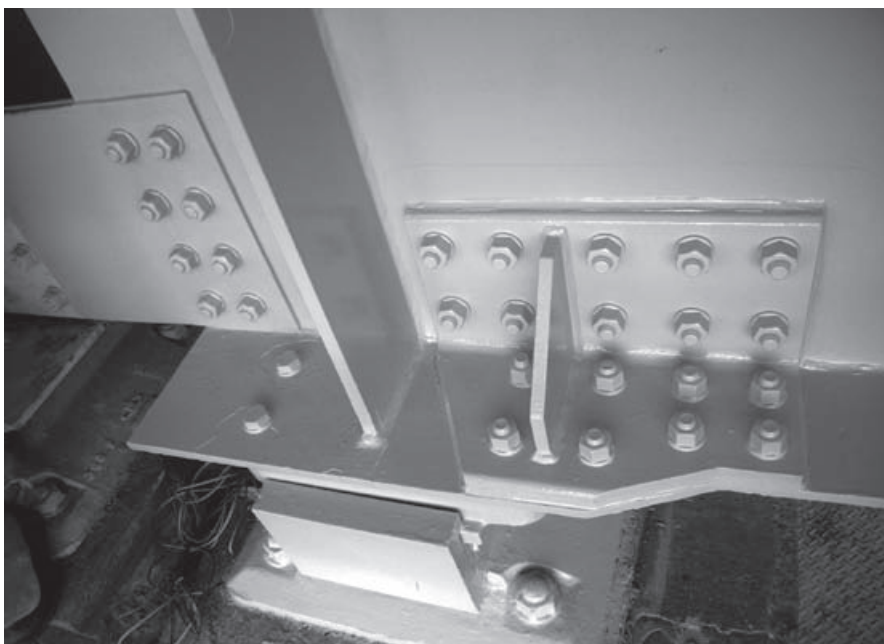
Reinforcement by patch plates

Corrosion and fatigue are the main durability problems on steel bridges. Regular periodic painting works have minimized corrosion despite the passage of about 40 years since steel bridges were first built on the San'yo Shinkansen. About 90% of these steel bridges (800 in total) are composite girder bridges and in recent years, fatigue cracks have been found around welded joints at the sole plate. Generally, the main factor causing these cracks is degraded bearing mobility (Fig. 3). Therefore, sole plate and bearing replacement are effective methods for reducing this fatigue damage. However, the cost is high, and development of an alternative repair method is imperative. An easy low-cost reinforcement method has been developed using FEM analysis and test construction. This method uses installation of angle steel with vertical ribs at the upper side of the lower flange to reinforce the fatigue-damaged welds of the sole plate.

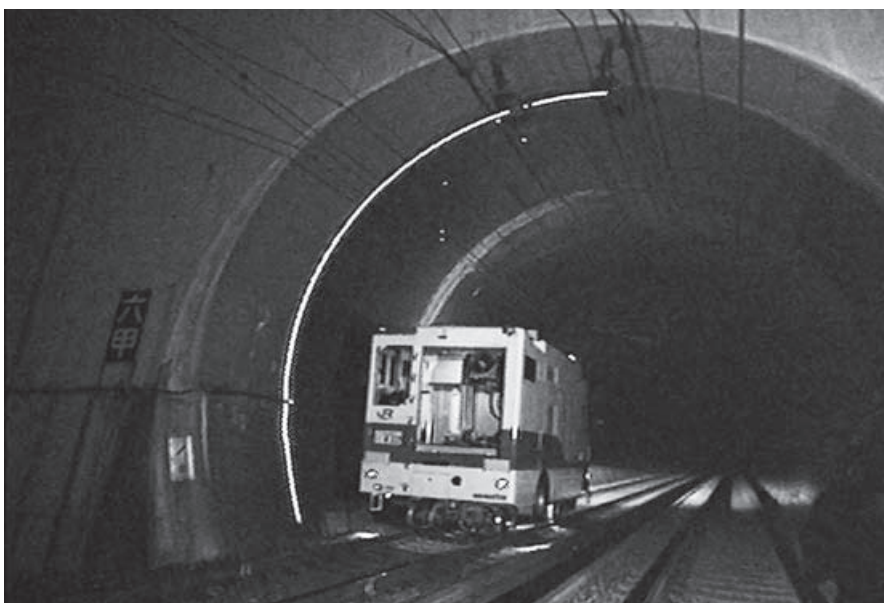
Tunnel lining surface imaging vehicle

At tunnel inspection, the condition of the tunnel lining must be determined accurately, reliably, and efficiently. The main method for inspecting tunnel surfaces is by eye, but maintaining uniform and continuous visual inspection is very difficult, and accurately recording findings is difficult too. Other problems include the possibility of human error. To solve these problems and improve inspection accuracy, we developed a tunnel lining surface imaging vehicle using a

laser detection system. It can operate at speeds up to about 9 km/h (when inspecting half the tunnel cross-sectional area), and can detect cracks just 0.5-mm wide.

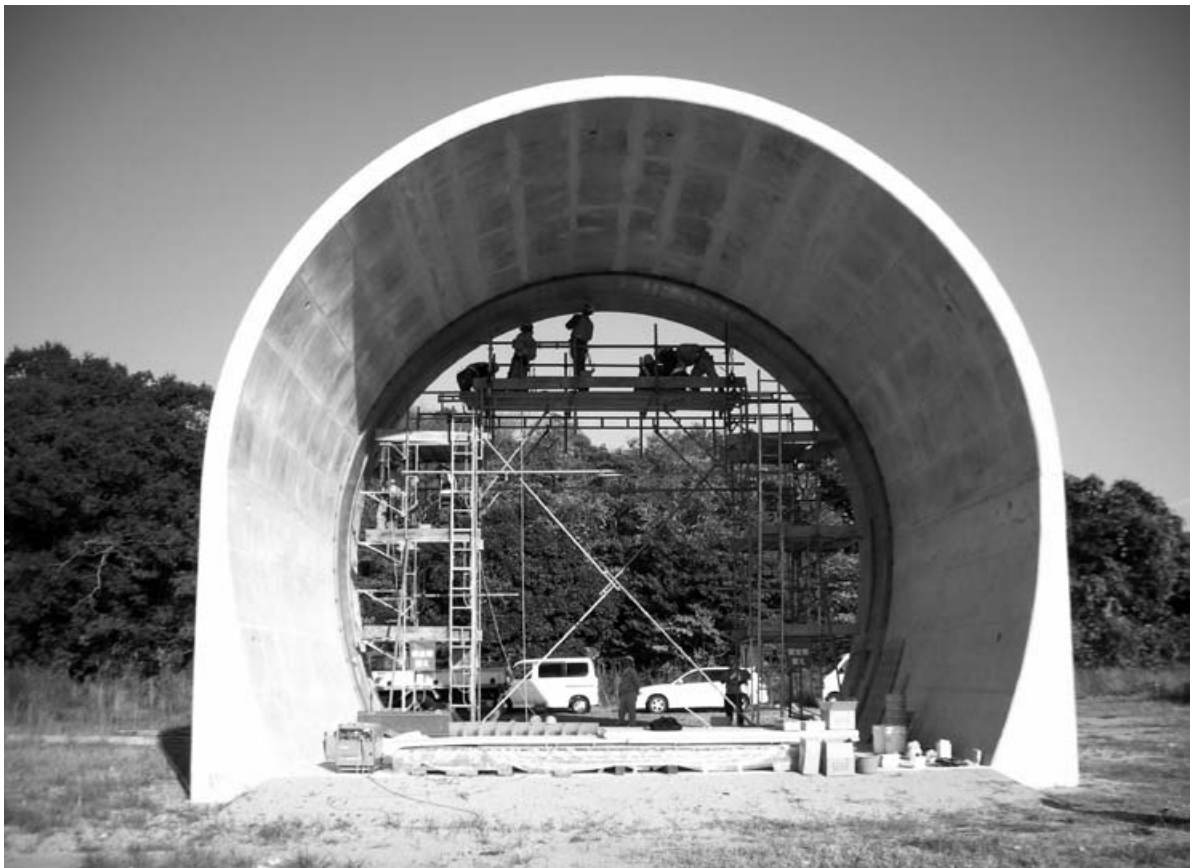
Full-scale tunnel for developing additional inner lining

Generally, tunnels are lined with plain concrete, but RC lining is used at tunnel portals or where the earth cover is shallow. Some of these linings have experienced progressive rebar corrosion due to lack of protective cover and use of salty beach sand and/or portland blast-furnace slag cement at construction, leading to surface concrete flaking. To prevent flakes falling off, loose parts are hammered frequently. Additional lining has been developed using fiber plastics and grouting as a basic countermeasure. The remediation method was tested and validated by constructing a full-scale shinkansen tunnel and the new method will be applied to some RC tunnel linings from 2013.

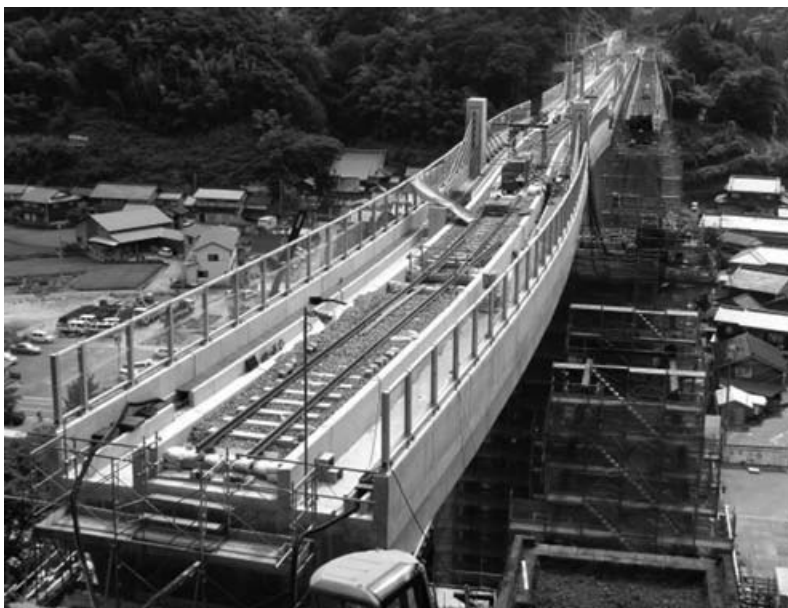
Lateral motion of girders and turning erection method (before)

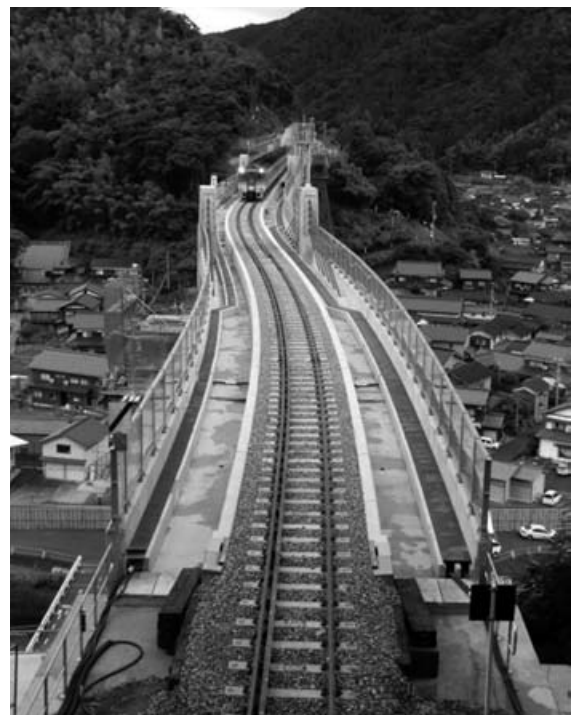
Lateral motion of girders and turning erection method (after)
