# Japanese Railway Safety and the Technology of the Day

### Masao Saito

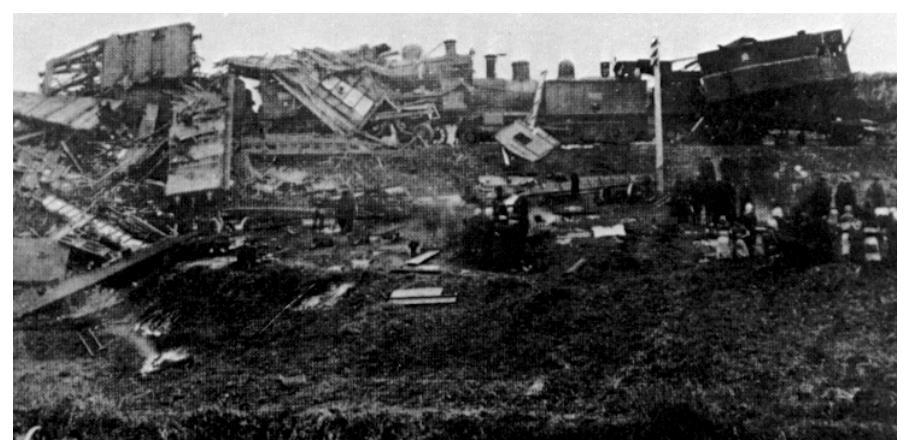
Two passenger trains in head-on collision between Shimoda and Furumagi stations on Tohoku main line (29 November 1916). The accident was due to a token error at Furumagi Station. (JNR CPH)

Two passenger trains collided head on between Shimoda and Furumagi in Aomori Prefecture on the single-track Tohoku main line, killing 20 people and injuring 180 others. The accident happened because after the track section was blocked, a member of the Furumagi Station staff with no operations qualifications tried to take a token from the block instrument due to a misunderstanding. The machine was locked because the other token had already been removed at Shimoda Station and he wrongly concluded that there was a fault in the block instrument. He inserted a lever against the rules to remove the token, which was given to the engine driver. As a result, the up train departed from Furumagi Station and collided head on with the down train from Shimoda Station.

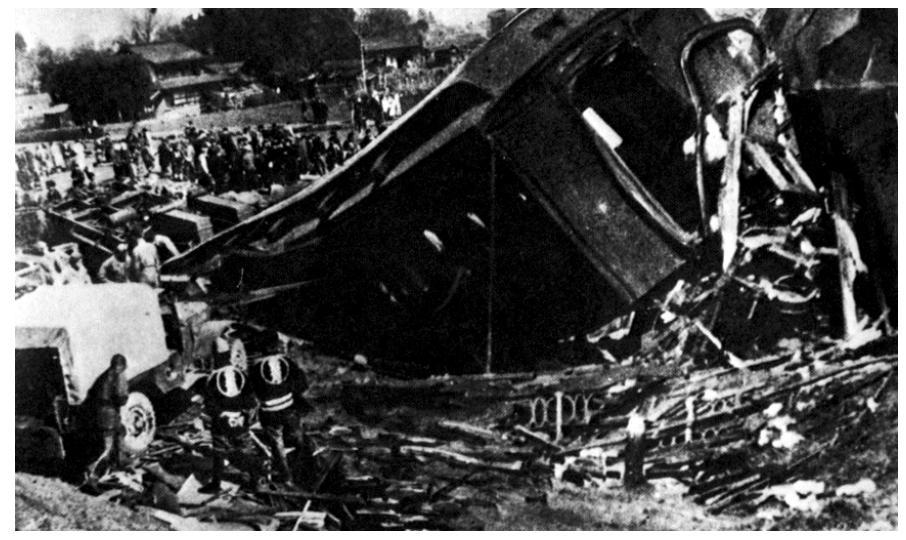
Train derailed off bridge between Higashi Hanno and Komagawa on Hachiko Line (25 February 1946). The accident was due to failure of worn-out rolling stock. (JNR CPH)

In this major accident, a train derailed while taking a curve too fast as it was speeding down a 20 per mill grade on the down line between Higashi Hanno and Komagawa in west Tokyo on the Hachiko Line. The derailed out-of-control train fell 5 m off a railway bridge killing 184 people and injuring 495. The accident was attributed to use of old worn-out rolling stock built with poor-quality wartime materials and to passenger overloading. In addition, the train driver had received insufficient training.

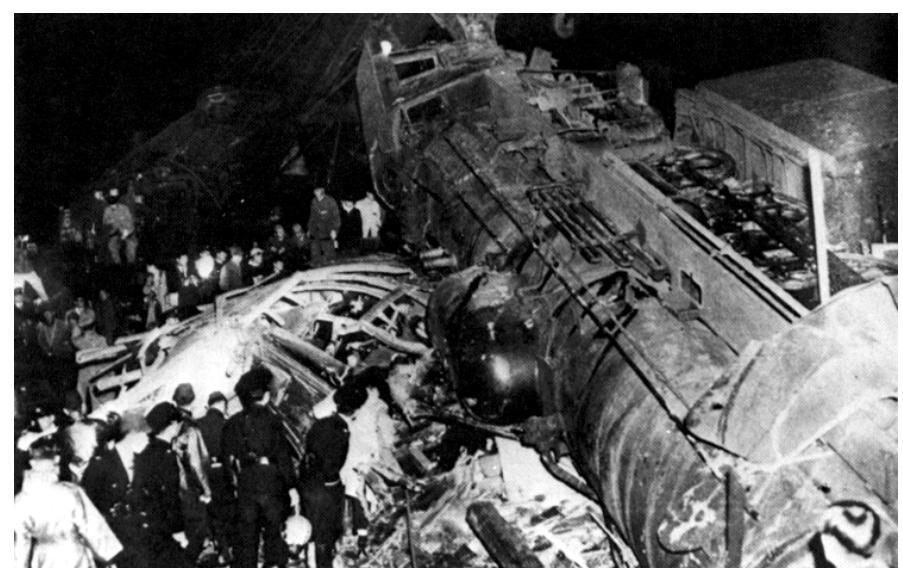
Two trains in collision at Rokken Station on Sangu Line (15 October 1956). The collision was due to the train driver misreading a signal and insufficient braking power. (JNR CPH)

This accident occurred when Rokken Station in Mie Prefecture on the Sangu Line received a special order to stop a double-headed passenger train on the down line bound for Toba that usually passed through the station. The station departure signal was showing the stop aspect but the passing signal at the station entry was showing the proceed with caution aspect. The train driver was in the habit of passing through the station so he proceeded without confirming the passing signal aspect but then suddenly realized that the station departure signal was showing the stop aspect. He applied the emergency brakes but could not stop in time and entered the safety siding at 27 km/h where the two heavy locos

derailed and overturned. The following three passenger carriages also overturned, blocking the up line. Then an arriving up train collided with the derailed train, killing 40 people and injuring 96 others.

Although the accident was primarily due to the train driver misreading the passing signal, the sudden increase in train frequencies sometimes necessitated this type of change in scheduled passing stations and the manual handling of the signals and interlocking to deal with these sudden changes was troublesome, resulting in an increased number of signal mistakes. Clearly, automatic signalling was needed. In addition, the increase in the number of long trains required doubleheading with heavy locomotives to haul them, necessitating upgrades to more powerful air brakes.

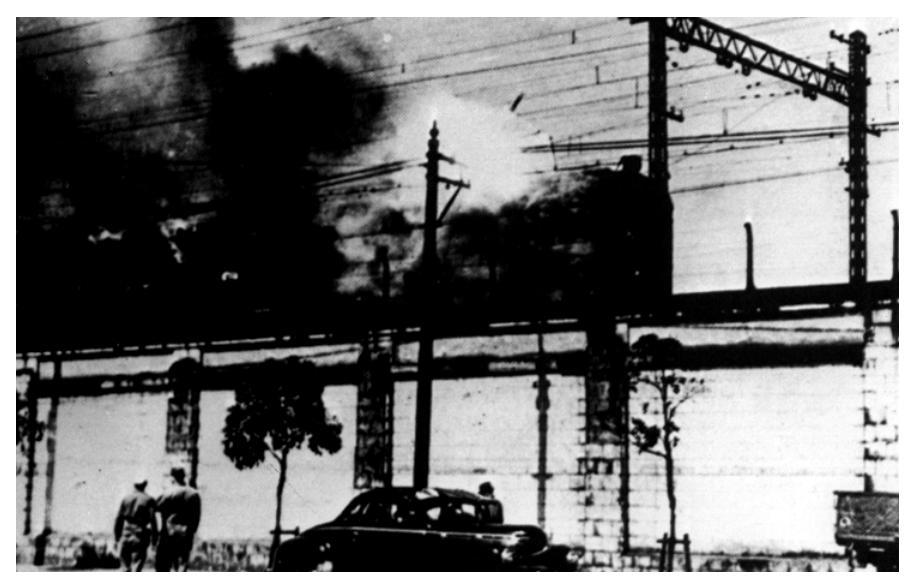
Train fire at Sakuragicho Station in Yokohama caused by sparks from overhead catenary during maintenance (24 April 1951) (JNR CPH)

This train fire at Sakuragicho Station (Yokohama) on the Keihin Line happened when a short circuit occurred in the overhead catenary during power maintenance work. The electric sparks set fire to an arriving train and the conflagration spread quickly to take the lives of 106 people and leave another 92 injured. Although the faulty overhead maintenance work was the initiating factor, the high death toll was aggravated by use of highly flammable materials and poor design conforming to low wartime standards. To save the cost of glass, the windows were too small to escape from and there was no through passage along the length of the train. Finally, the electrically operated doors could not be opened when the power had been cut.

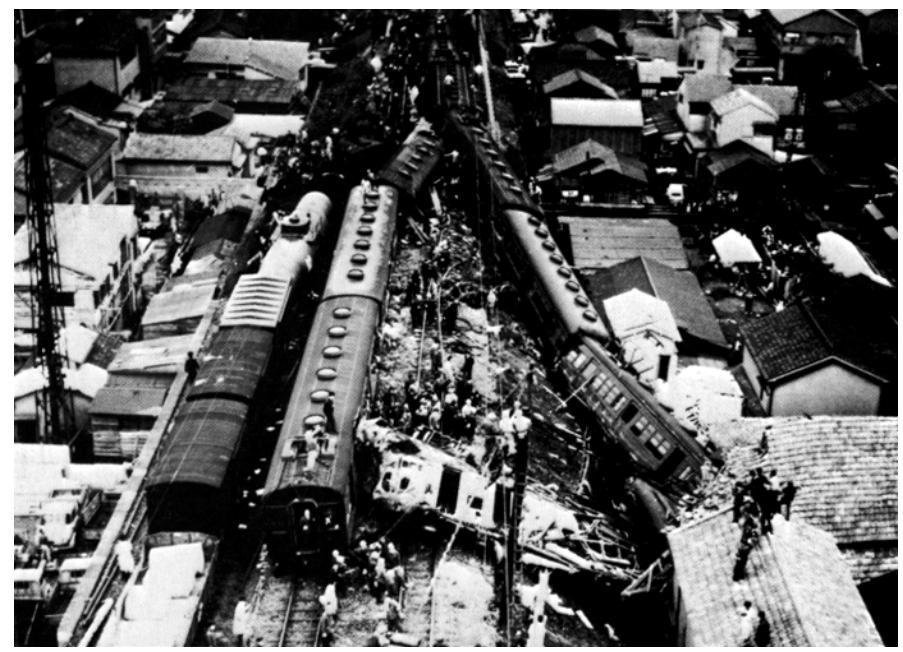
Multiple collision on Joban Line near Mikawashima Station, Tokyo (3 May 1962)

This catastrophic accident occurred in Tokyo as a freight train from Tabata Station on the down Joban freight line was climbing a 10 per mill grade at 35 km/h to join the main line at Mikawashima Station. The departure signal on the freight line was showing the stop aspect to allow an EMU passenger train on the down main passenger line to leave the station. But the driver of the freight train ignored the signal and broke through onto the safety siding where the loco and first tanker wagon derailed to block the down passenger line. The EMU departed on the down line and struck the derailed freighter to derail and block the up line. Finally, an EMU composed of six carriages arrived on the up line to collide with the two derailed trains, resulting in a total of 160 lost lives and 296 injuries.

The ignoring of the departure signal by the driver of the freight train started this accident sequence but the Mikawashima stationmaster failed to notify Minami Senju Station up the line as soon as it happened. Moreover, insufficient training had been given in use of the signal fusee, which was supposed to prevent this type of multiple sequential accident.

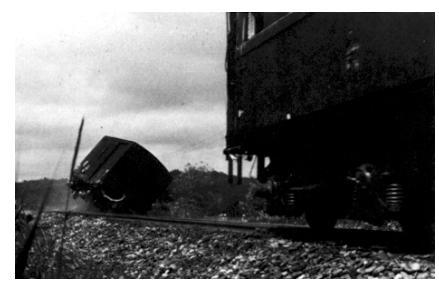
Derailment experiments conducted by RTRI on test track using same rails and rolling stock (JNR CPH)

A JNR accident investigation committee was immediately convened. The first question was why did the freight train derail? Its speed of 60 km/h was not unusual and no problems were found with the wheel flanges, axles, springs, couplers or air brakes. The track was also found to be OK. So what initiated the derailment? Tests were conducted for 5 years by the Railway Technology Research Institute (RTRI) on a test track using the same rails and rolling stock. They discovered that the combination of wheelset design and

tyre profile, rail cross section and wear, and track geometry all played a role in the derailment.

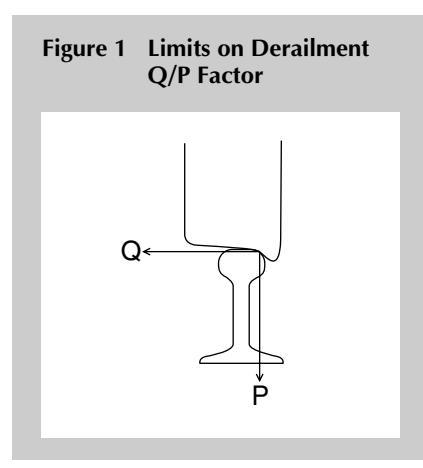
- Limits on derailment Q/P factor (Fig. 1)
- Tyre profile
- Rail profile
- Rail longitudinal irregularity limits
- Rail vertical irregularity limits
- Track gauge irregularity limits
- Track flatness irregularity limits
- Adhesion limits (wheelslip and slide prevention)
- Catenary wire and pantograph separation
- In-carriage and external running noise reduction
- R&D into human performance limits at high speeds of operations and maintenance staff
- Natural-disaster countermeasures (typhoons, earthquakes and flooding)
